## Challenge

Corrosion of valve due to failed rubber lining led to leaks and environmental fines totaling >\$200K.

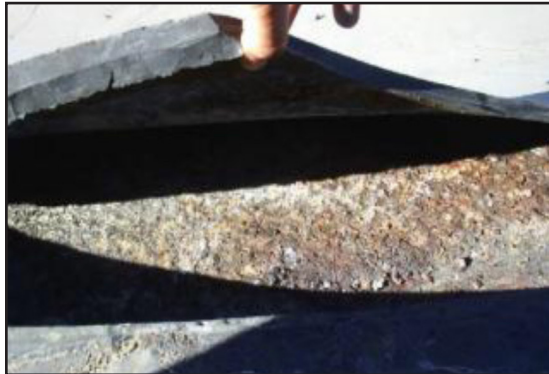
15% H<sub>2</sub>SO<sub>4</sub> vapors at 120°F (50°C), under vacuum of 1 bar (14.5 psi), attacked rubber lining.

*Delaminated rubber liner with corrosion underneath*

- Remove rubber lining by UHPWB at 40 kpsi (2,600 bar)
- Grit blast to Sa 2.5 with 3 mil (75 μm) angular profile

1. **ARC 858** used to rebuild corroded and pitted valve disc and body
2. Apply **ARC BX2\*** for abrasion resistance of valve disc
3. Topcoat valve body with **ARC S4+** for chemical resistance

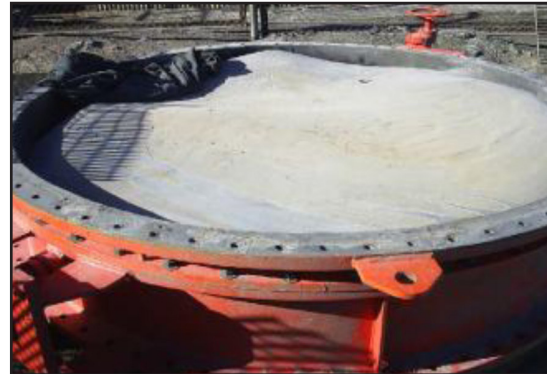
*Disc before rubber removal*

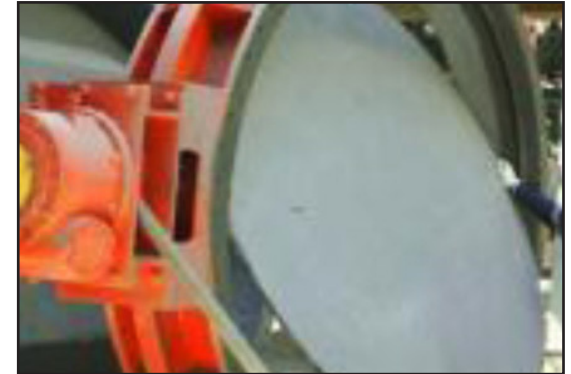
*Completed valve with ARC S4+ topcoat applied*
