## Challenge

The pump required disassembly and recoating every 2 years.

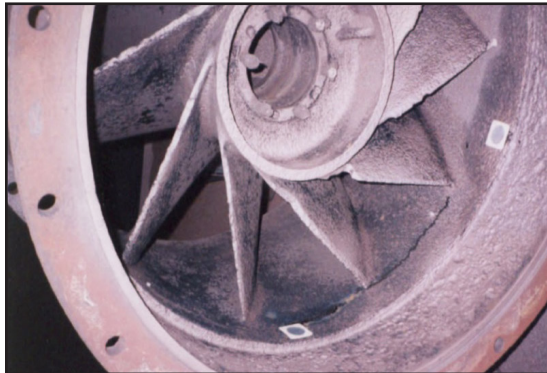
The coal tar epoxy coating suffered under-film corrosion resulting in severe pitting and subsequent performance loss.

Pump condition after removal of the old coal tar coating

- Remove old coating
- Clean of contaminates and soluble salts
- Abrasive blast to Sa 2.5 with 3 mil (75 µm) angular profile

- Rebuild pump to original dimensions using [ARC 858](#)
- Restore critical tolerances using [ARC 858](#)
- Apply 2 coats of [ARC 855](#)

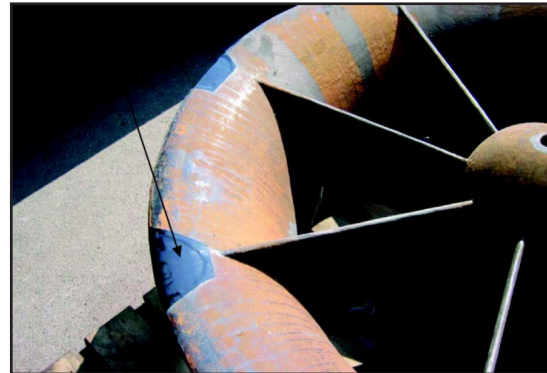
Suction intake after 10 years service. A few small spot repairs were required

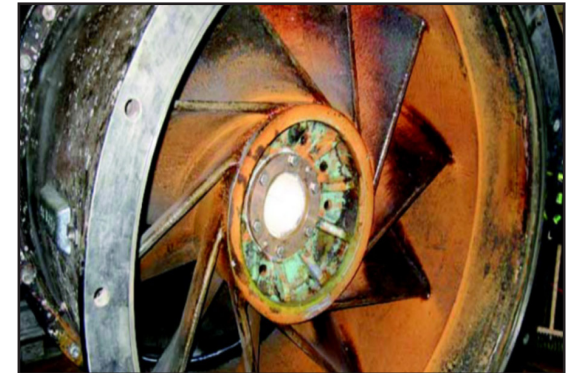
Diffuser after 10 years. The red color is due to a corrosion inhibitor that leaves a thin deposit on the ARC coating
