Challenge

Root Cause

Corrosion from H₂S gas attacked an ineffectively protected frame structure. Erosion abrasion from solids removal was accelerating attack.

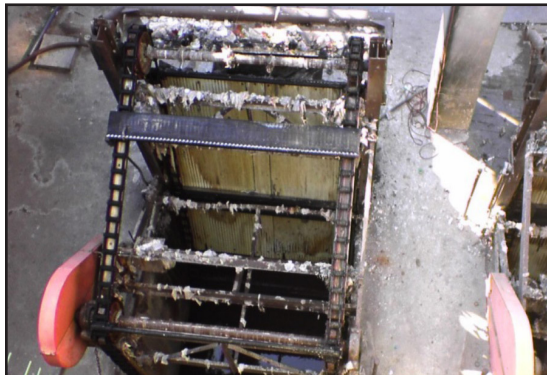
Screen in operation prior to coating

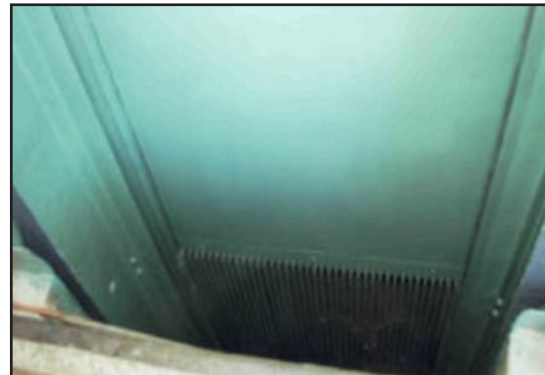
Screen frame surface after coating

- Pressure wash and decontaminate surfaces
- Grit blast to Sa 2.5 with 3 mil (75 µm) angular profile

- Apply two coats of **ARC S2** to internals for corrosion/erosion resistance

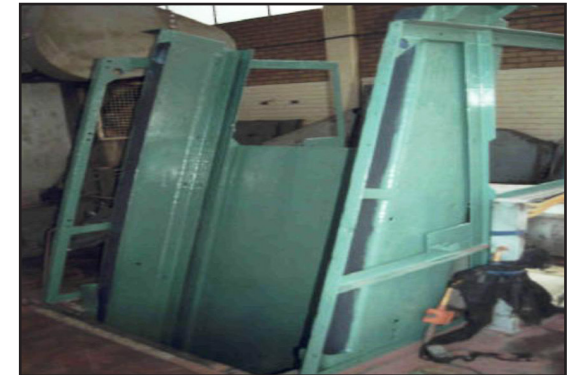
- Doubled 5 year service life
- **ARC S2** optimally performed for over 10 years
- Plant data indicates that bar screen associated maintenance activities are negligible
- Based on previous repair costs, the estimated savings, less the cost of the ARC solution

ARC coated surfaces
