Challenge

Issue

After 20 years in service, corroded pump internals reduced flow and efficiency. Client sought options to high capital replacement cost with long lead time.

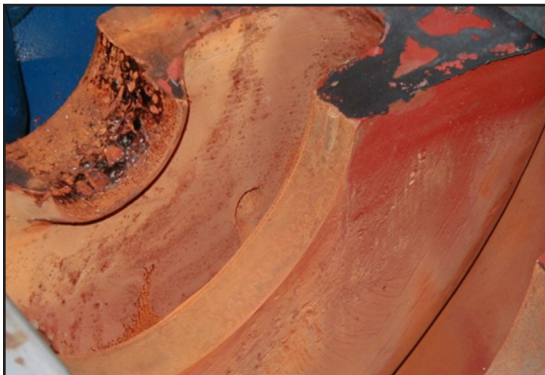
Corrosion and erosion from entrained solids degraded internal tolerances and increased frictional drag through hydraulic passages.

Eroded and corroded pump volute

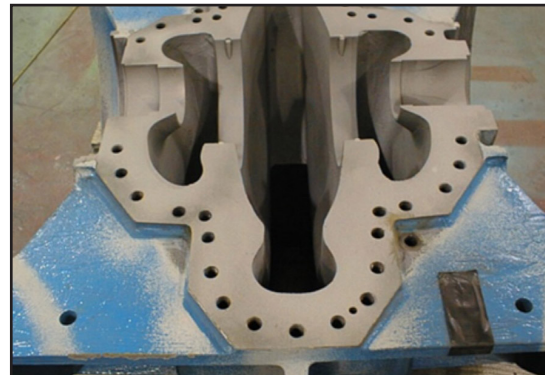
Surface after proper surface preparation

- Decontaminate surfaces
- Grit blast to Sa 2.5 with 3 mil (75 µm) angular profile

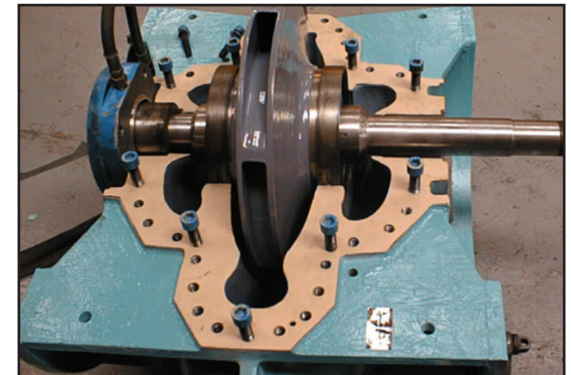
ARC-coated surfaces - casing and impeller

1. Apply **ARC 858** to fare smooth and fill pitted surfaces rebuilding tolerances
2. Apply 2 coats of **ARC S2** @ 15 mils (375 µm) DFT per coat
