## Challenge

Severe pitting corrosion throughout the vessel led to an immediate need for repair or risk failure of the deaerator which is required to maintain well production O<sub>2</sub> levels.

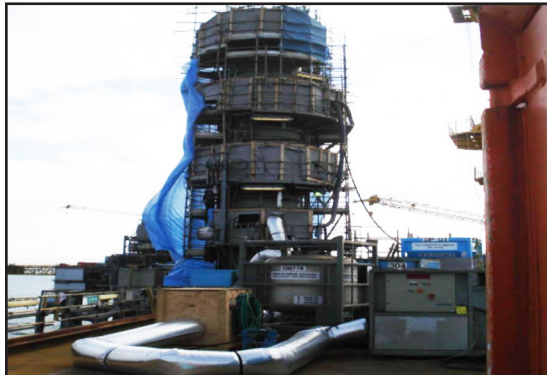
Failure of previous lining exposed steel to a highly corrosive, chloride, and O<sub>2</sub> rich environment at elevated temperature.

Deaerator on offshore platform

- Grit blast remove residual failed lining
- Decontaminate to remove chlorides
- Abrasive blast to Sa 2.5 with 3 mil (75 µm) surface profile

1. Stripe coat welds with **ARC S2**
2. Spray apply 2 coats of **ARC S2** total DFT of 32 mils (800 µm)

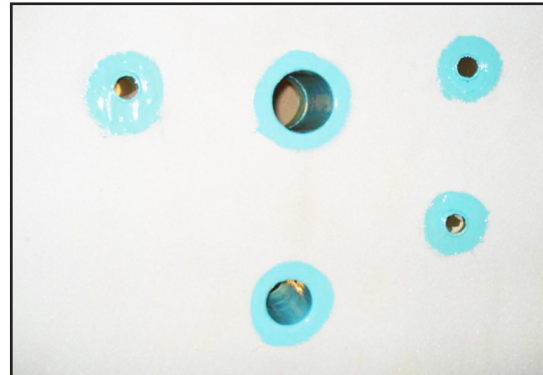
Preformed ARC sleeves for nozzles <2" OD

**Note:** Repair nozzles <2" (5 cm) OD using preformed sleeves made of **ARC S2** with carbon fiber cloth.

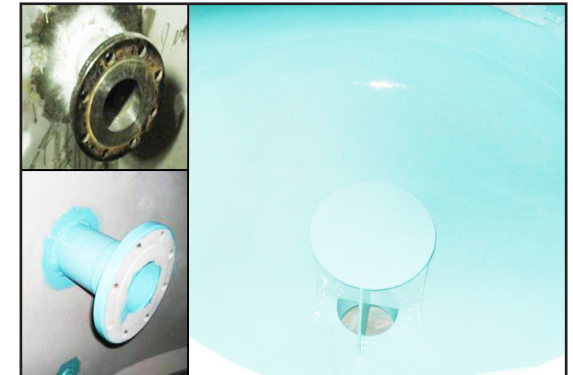
- ARC lining was installed in 2009
- At 5 years, no evidence of corrosion has been found and no repairs associated with protected areas have been required
- This exceed their reliability based maintenance cycle by 66% allowing deaerators to go to 4 year inspection cycle as opposed to 3 years

Finished Application of ARC S2
