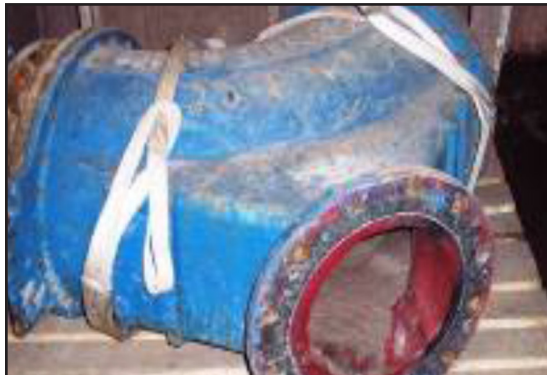
Rubber-lined valves were clogging every 3-4 months, requiring frequent shutdowns to clean out system. Where rubber liner failed, valve body was heavily eroded and required weld repair.

Highly abrasive slurry erodes valve liner, resulting in sheet delamination and eventual restriction or plugging of flow.

Rubber-lined valve body suffering from rubber delamination

- Cut out failed rubber liner; patch weld valve body; decontaminate to remove residual chlorides
- Grit blast to Sa 2.5 with 3 mil (75 µm) angular profile

1. Apply **ARC MX1** @ 240-375 mils (6-9 mm) as a monolithic liner to match with inlet and outlet piping

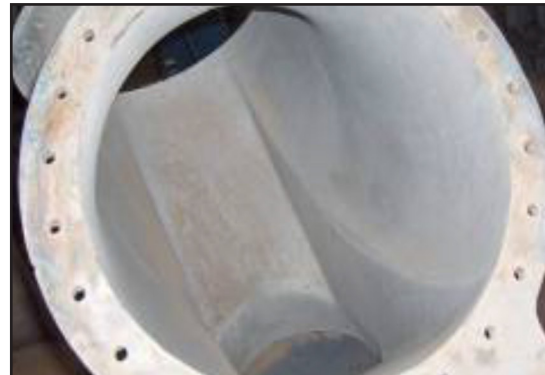
Properly prepared valve body

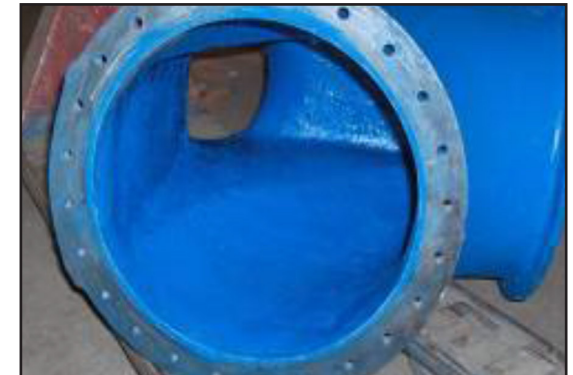
Completed valve body ready for service

- Valve life has been extended from 3-4 months to >1 year
- Plant production is no longer disrupted by plugged valves
