Challenge

Issue

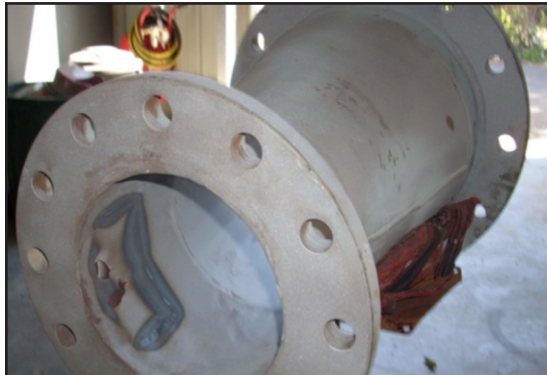
Tile lined spool pieces last <6 months before delaminating and damaging downstream piping and valves, effecting production. Exposed steel wears rapidly and requires weld repair.

Abrasion and impact of 2" (50 mm) rock and clay particles at spool neck cracks tiles, leading to disbondment and clogging.

Spool piece after 4-6 months with tile removed and weld patch over hole

- Remove remaining tiles
- Grit blast to Sa 2.5 and 3 mil (75 µm) angular profile

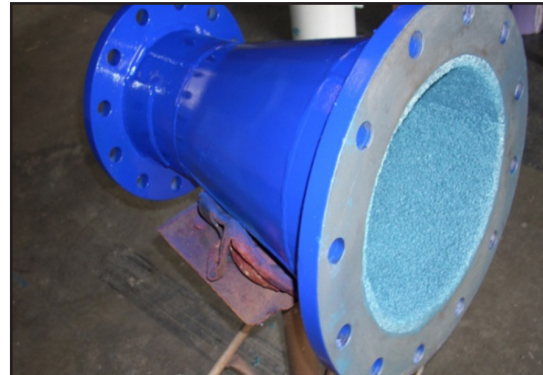
Newly coated spool piece

1. Apply **ARC MX1** @ 500-600 mil (12-14 mm) to mate with upstream and downstream liner thickness

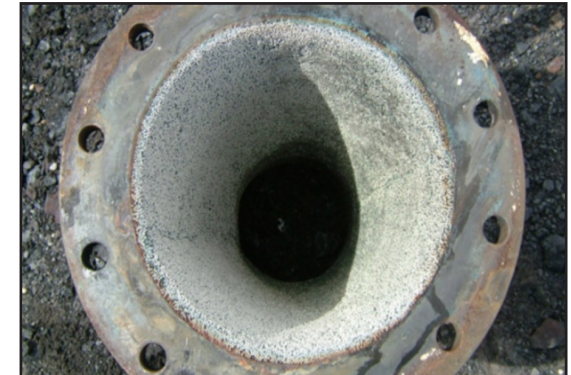
- Spool piece was inspected after 6 months and found to have 85% of original coating thickness
- Unit went back into service for 6 more months before relining
- ARC solution total run time: 12 months
- **ARC MX1** specified replacing ceramic tiles

Spool after 6 months with over 85% of original thickness remaining
