## Challenge

The existing bitumen lining in an effluent dosing pit was failing, resulting in acid attack on exposed concrete. If waste dosing pit leaks, the plant is at risk for environmental fines.

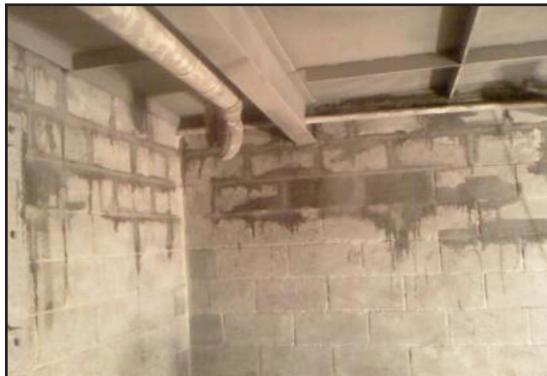
Water blasting and grout patched concrete

- High-pressure water blast to remove failing bitumen lining on concrete and steel surfaces.
- Blast surfaces to SP10 for metal and CSP#3 for concrete

1. Apply **ARC 791** to patch degraded concrete
2. Apply **ARC S1HB** by heated plural component spray to a dry film thickness of 2.5 mm (80 – 100 mils)

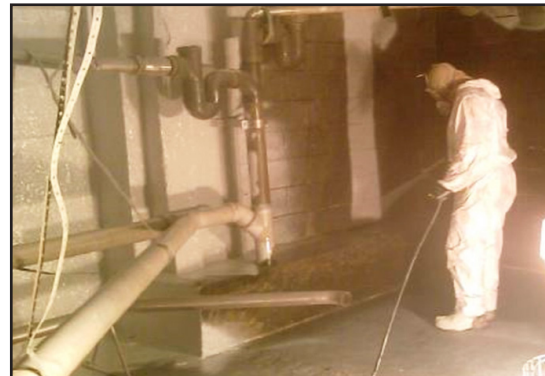
Applying **ARC S1HB** by heated plural component spray

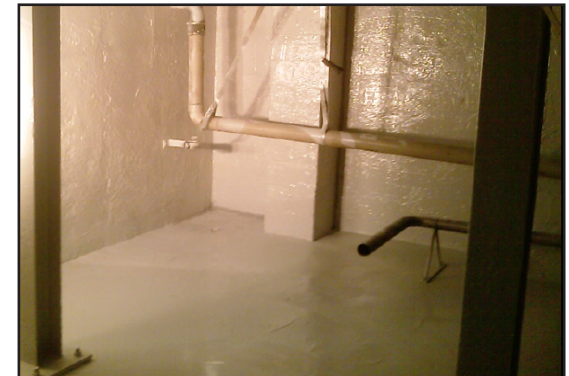
New lining continues to be free of flaws or failure as of 9+ years.

Finished surface
