Challenge

Issue

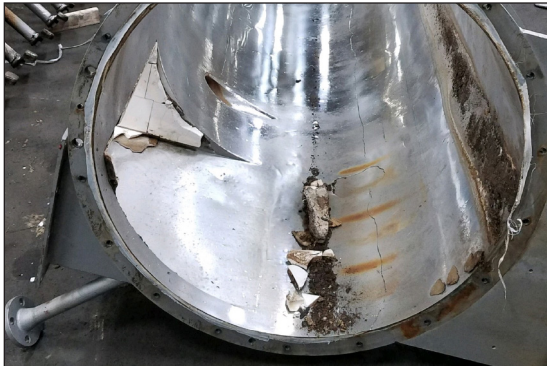
Severe abrasion from corn milling residues used in animal feed processing result in severe abrasion to mixer internals.

Signs of abrasive wear to internals of mixer.

To reduce or eliminate requirements to weld repair mixer and carry out any future repairs on site by using an FDA compliant wear-resistant liner.

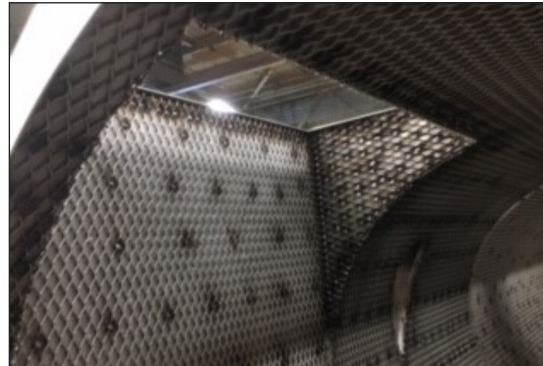
Tack welding expanded metal mesh for increased structural integrity.

Decontaminate and abrasive grit blast to SP10 cleanliness with 3 – 5 mil angular profile.

ARC MX FG was trowel applied between 6 – 9mm (.25 – .325") and then two alternating color coats of ARC S1PW were applied as a smoothing coat and a wear indicator coat to identify when the top 20 – 30 mils of coating have been removed.

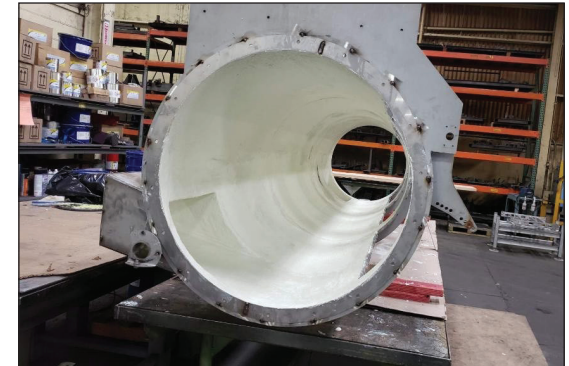
After 90 days in service client inspected and noted minimal wear to ARC S1PW coat and no sign of any wear to ARC MX FG layer.

ARC MX FG coated mixer internals.
