Challenge

Tank roof had holes due to corrosion. Structural repairs were needed to maintain integrity of tank roof.

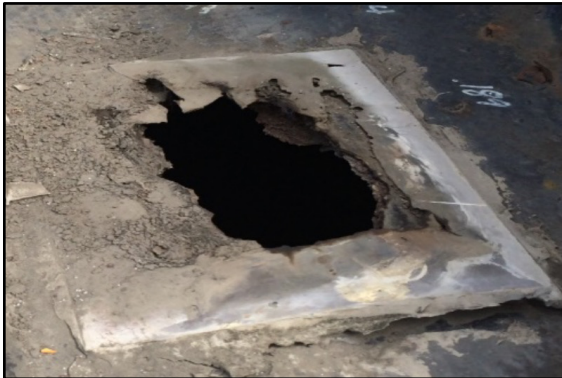
High sulfur level in oil resulted in corrosive SO₂ gas which reacted with humidity in tank and formed H₂SO₄, which corroded tank.

Before: Damaged tank roof.

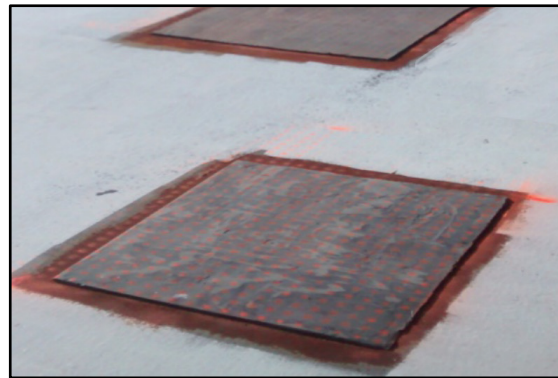
In progress: Metal plates cold welded with ARC 858.

1. Metal plates were cold-welded onto the roof using ARC 858.
2. Expanded metal mesh embedded within the ARC 858 coating for additional structural support.

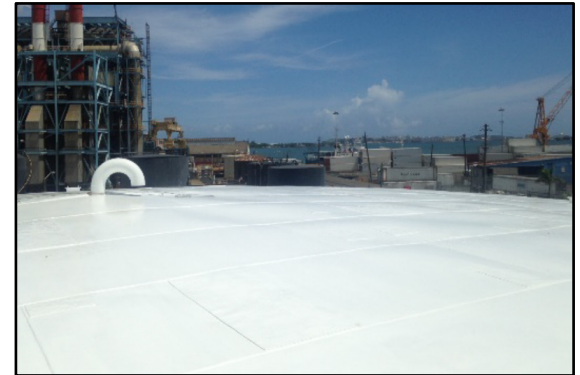
After: Finished repairs and top coated external of tank roof.
