Issue

The existing green liquor clarifier had sprung several leaks and severe pitting corrosion had affected the tanks primarily at their weld zones.

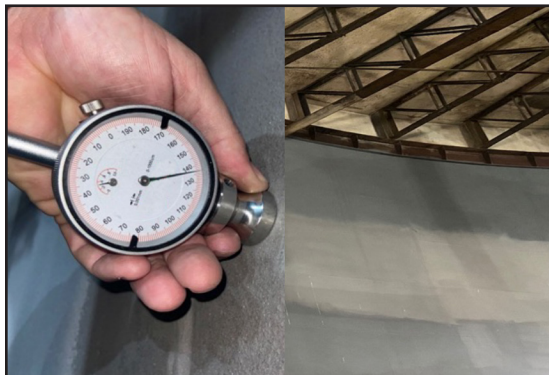
Blasted wall. Verifying cleanliness and profile prior to coating.

Areas where the leaks had occurred were replaced with fresh steel. All surfaces were HP water washed and then were grit blasted to Sa 2.5 with a 75 – 125 µm (3 – 5 mil) angular profile.

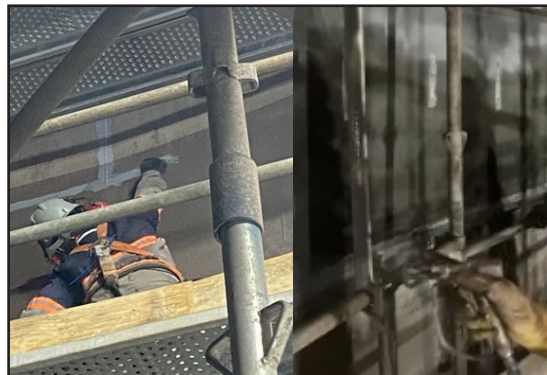
Stripe coating weld seams and spraying first coat of ARC S5 Coating.

Chesterton® ARC 858 Abrasion Resistant Rebuilding and Faring Composite was applied as a stripe coat to all weld zones. ARC S5 Coating was then spray-applied in two coats of 375 – 500 µm/coat for a total DFT of 0.750 – 1 mm.

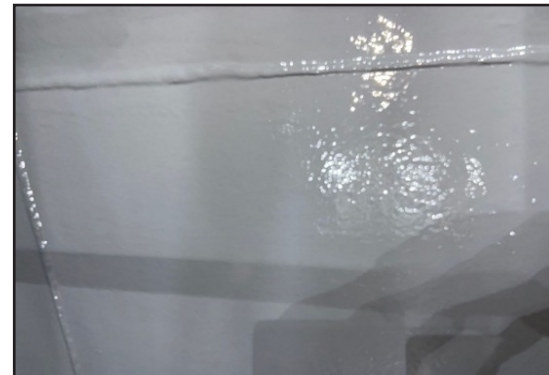
Final DFT of 0.75 – 1mm.
