Challenge

Impaired pump efficiency diminished steam condenser cooling capacity, reducing power output.

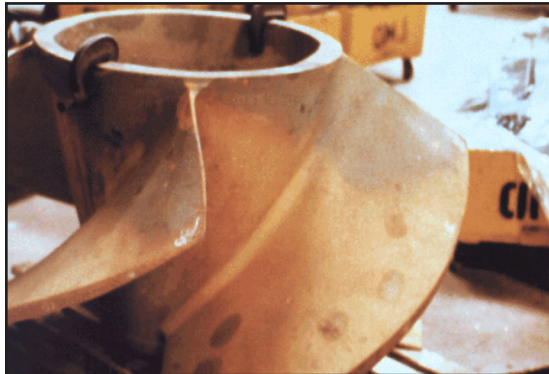
Pumping seawater with entrained sand at a high flow rate caused corrosion erosion damage to impeller, impeller vanes and leading edges.

Worn leading edge of impeller

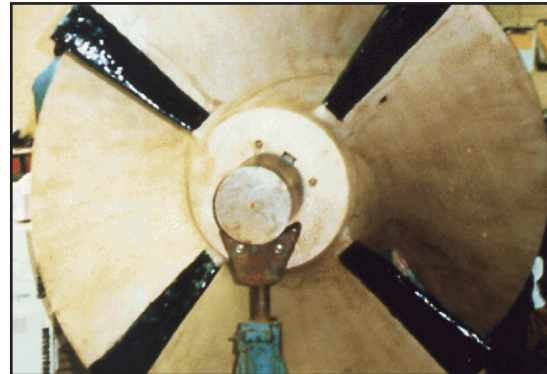
Leading edge rebuilt with ARC 858

- Pressure wash and decontaminate surfaces to eliminate soluble salts
- Machine leading edges back by 1,5 mm (0.060")
- Grit blast to Sa 2.5 with 3 mils (75 µm) profile

1. Rebuild leading edges flush with [ARC 858](#)
2. Apply 2 coats of [ARC 855](#) ~DFT: 60 mils (1.5 mm) alternating colors to monitor wear rates

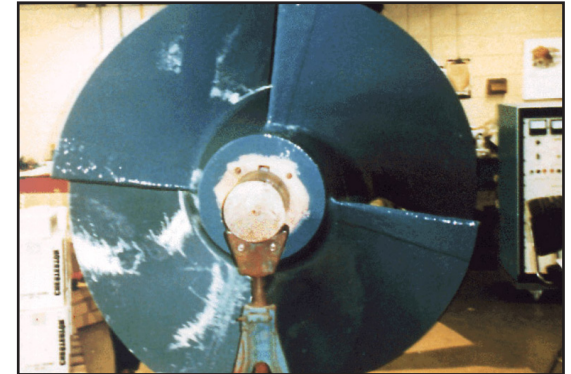
- Goals of improving operating efficiency and increasing power production were achieved
- Impeller has remained in perfect condition
- NOTE: After 9 years of pumping salt water and sand, the “brush marks” are still evident and pump is performing required duty point

Follow up inspection after nine years shows no wear
