Challenge

Excessive damage to pump internals was reducing performance after only 5 years resulting in reduced base load operating efficiency of plant.

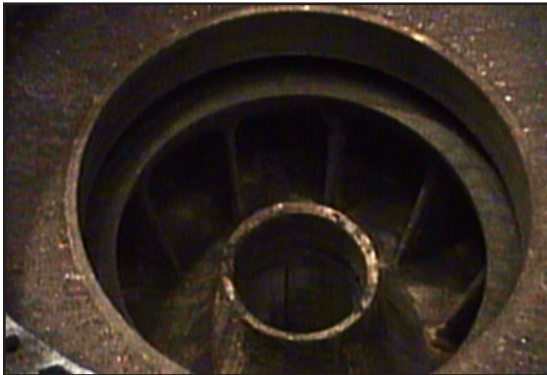
Entrained solids coupled with high flow caused erosion and corrosion issues.

Erosion and corrosion of the pump after 5 years operation in river water

1. Apply **ARC 858** to rebuild eroded sections of pump
2. Apply 3 coats of **ARC 855** @ 15-20 mils (375-500 µm) per coat to entire wet end
3. Rebalance impellers

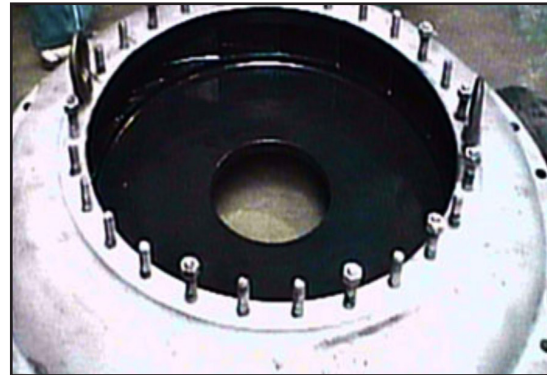
ARC 855 installation in the pump volute

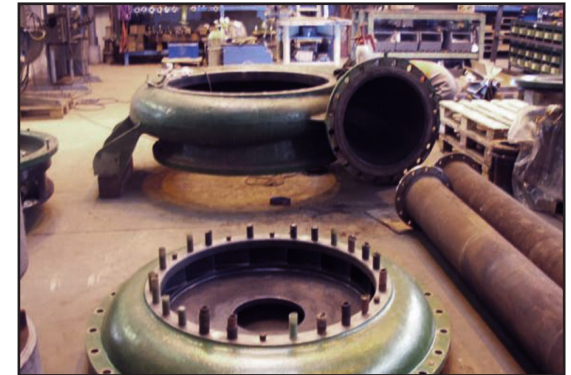
After 10 years of operation, the ARC 855 coating shows no damage
