## Challenge

### Issue

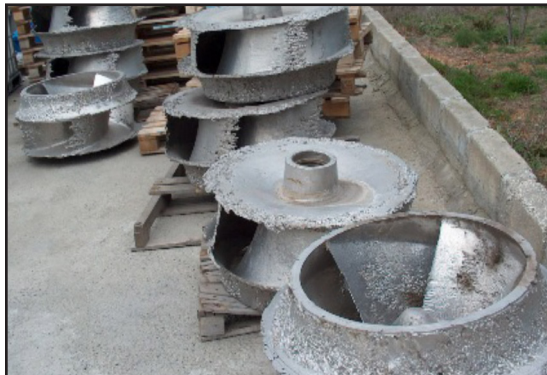
15% limestone slurry with high chloride level at 70,000 ppm attacks stainless steel welded parts.

Impellers after <12 months

1. Apply **ARC MX1** @ 500-1000 mil (6-12 mm) to restore original dimensions
2. Apply **ARC 855** @ 30 mil (750 µm)
3. Balance impeller

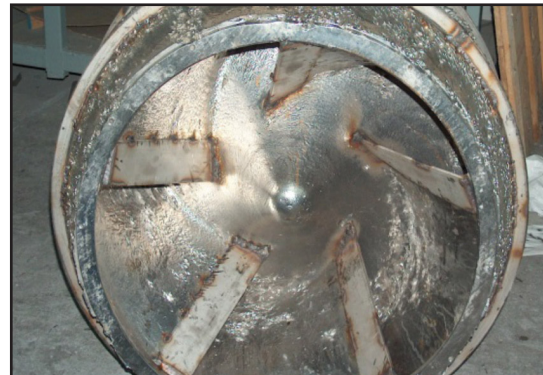
Weld repairs to the impeller vanes

- Weld plates to impeller vanes
- Decontaminate surface
- Grit blast to Sa 2.5 with 3 mil (75 µm) angular profile

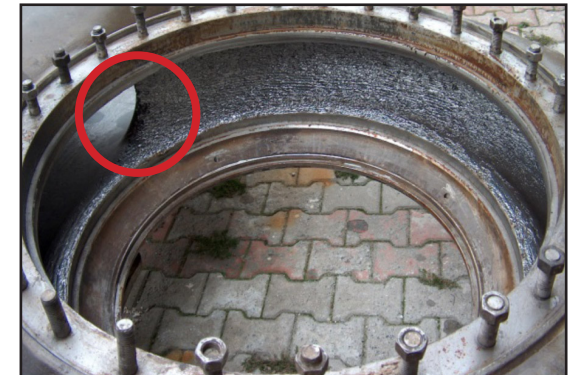
Casing after 12 months with ARC showing a small area requiring repair at the cutwater
