Challenge

An OEM installed several large (14.250") seals on vertical wastewater pumps. The pumps continuously failed over several months resulting in warranty service calls and downtime costs. The OEM needed a method that would help them identify the causes of pump failures to help them improve pump uptime.

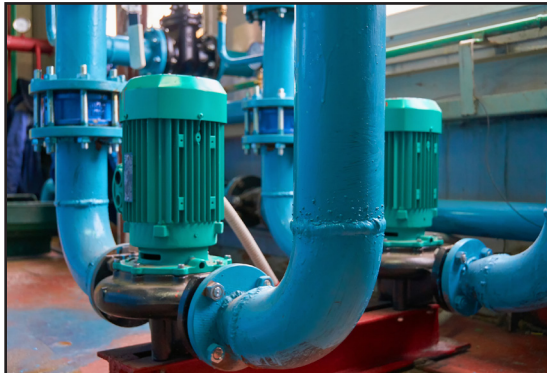
Vertical wastewater pumps.

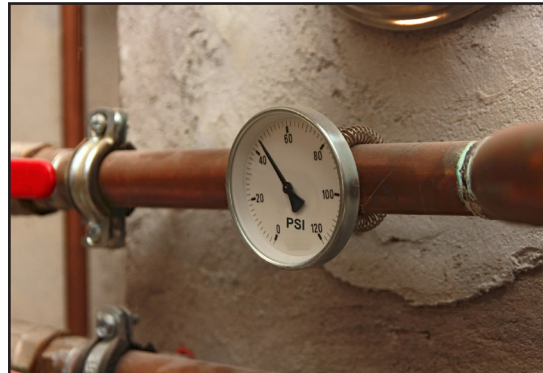
The end user was sure they had adequate Plan 32 flush flow and pressure to the seal. The dial pressure gauge on the Plan 32 support pump indicated 42 psi. However, the support pump providing the seal water flush was very far from the main pump where the OEM's seal was failing. After a seal failure analysis was performed, we recommended the **Chesterton Connect™ Sensor** to be installed directly at the seal's flush line inlet to determine what the problem was.

Plan 32 support pump dial pressure gauge.

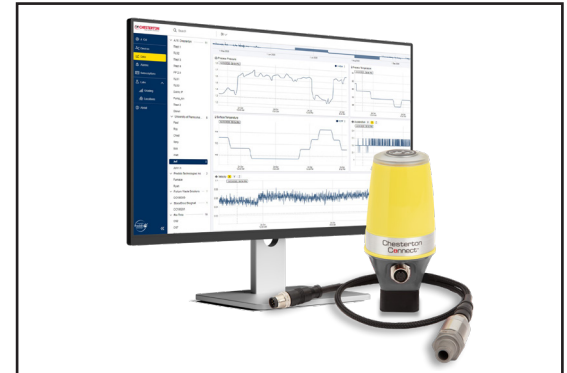
Data from the **Chesterton Connect Sensor** was recorded 24/7 and confirmed that there was low flush pressure at the seal chamber (despite a manual gauge showing adequate pressure). A previously undetected strainer was found clogged in the Plan 32 flush line between the support pump and the main pump.

Chesterton Connect System data showed low flush pressure.
