Challenge

Chemical spills during unloading attack concrete and increase the risk of environmental release.

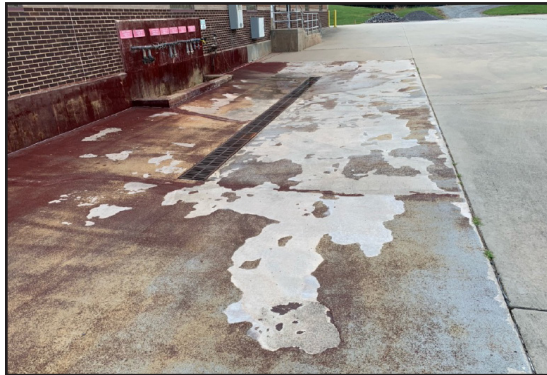
Acid with pH <4 rapidly attacks concrete.

Deck floor coating condition before applications.

The existing coating was removed by chipping hammers and then all surfaces were grit blasted or diamond ground to CSP 3 finish minimum.

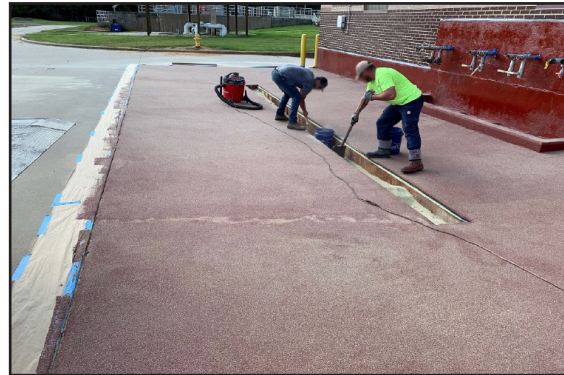
Non-skid coat applied to the deck with forms set in "U" drain for repairs.

Chesterton® ARC EG-1 was used to help repair chemical damage and to help maintain pitch for the center drain.

After ARC EG-1 had cured for 24 hours, a 20-mil thick sealer coat of Chesterton ARC NVE Veil Coat was applied with a non-slip broadcast and a final scrim coat of ARC NVE Veil Coat.

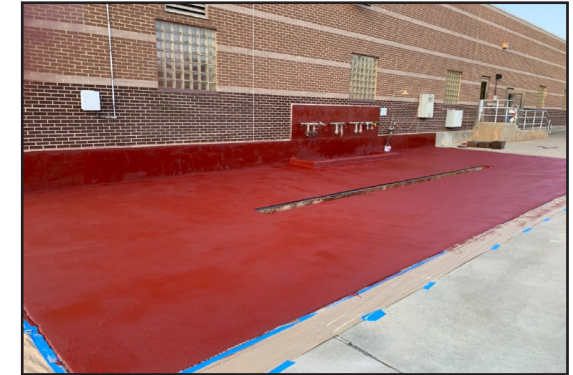
Completed deck with sump prepared for forming with ARC EG-1.

- Repairs were carried out quickly and efficiently.
- The liner has been in service for >24 months with minimal signs of damage or excessive wear.
- ARC EG-1 is now a plant standard floor repair compound.
- The client is now using ARC NVE in other chemical holding bays throughout the plant.
