## Challenge

- Convert a Worthington VTP Hotwell Pump from packing to a **Chesterton 442™ Split Seal**. Years of leakage had damaged the face of the stuffing box face. The shaft was also severely pitted.

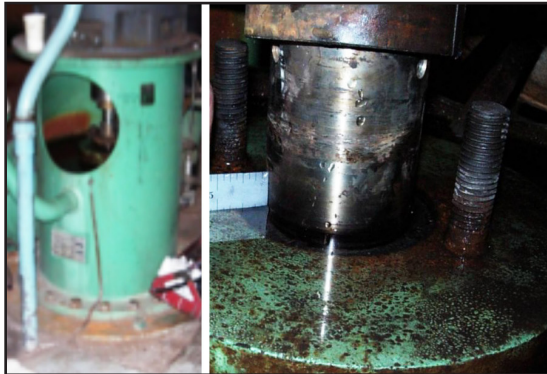
- Sealing the **Chesterton 442** gland to stuffing box face, and seal sleeve to pump shaft was not possible due to the pitting corrosion.

Condensate leaking from the Hotwell Pump had corroded the shaft and pump face.

- Since the pump could not be removed for machining of sealing surfaces, a split adapter plate was used to create a “new” stuffing box face and position the seal to a “clean” area of the shaft.
- Chesterton 860™ Moldable Polymer Gasket (MPG)** was used to seal the adapter plate halves and the plate to the damaged stuffing box face.
- The unique 2-component, non-adhesive technology made a complete cure, even through thick sections and across the wide flange.

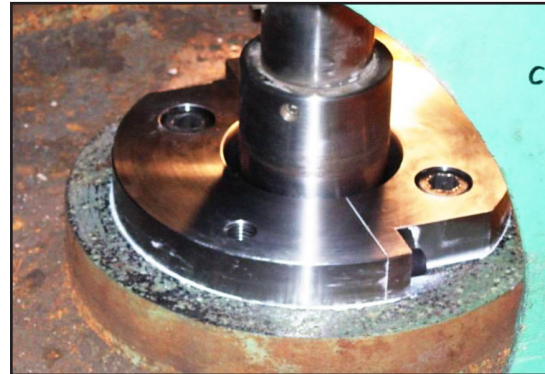
Chesterton 860 MPG cures to form a perfect “form In place” gasket to seal the adapter plate.

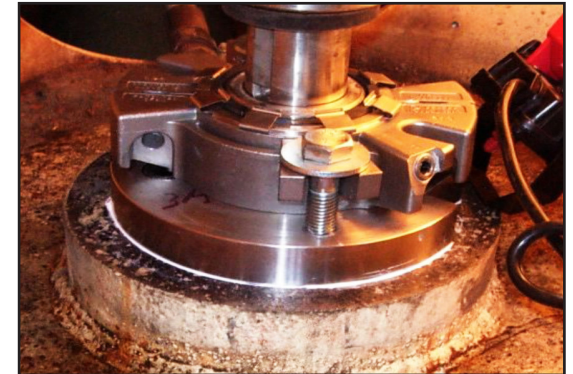
Repaired and leak-free sealing with Chesterton’s 860 MPG and Chesterton 442 Split Seal.

- Chesterton 860 MPG** reduced the time to convert the pump from packing to the **Chesterton 442 Split Seal** to 8 hours.
- Pump conversion required no disassembly, machining or new pump parts.
