Challenge

Restore a critical cooling water pump back to optimal efficiency to increase output and reduce electric costs.

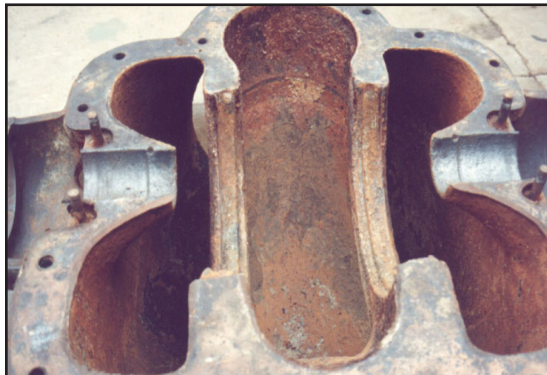
Customer was considering purchasing new pumps at a cost of almost \$14K

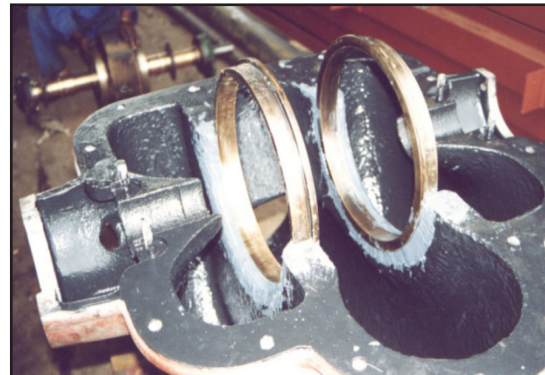
Cooling water pump from sugar mill repaired using ARC 858 and ARC 855

1. Apply **ARC 858** to areas of severe corrosion pitting and rebuild “wear ring” seats
2. Apply 3 coats of **ARC 855** with DFT of 350 microns (14 mils) per coat for abrasion and corrosion protection and enhanced flow

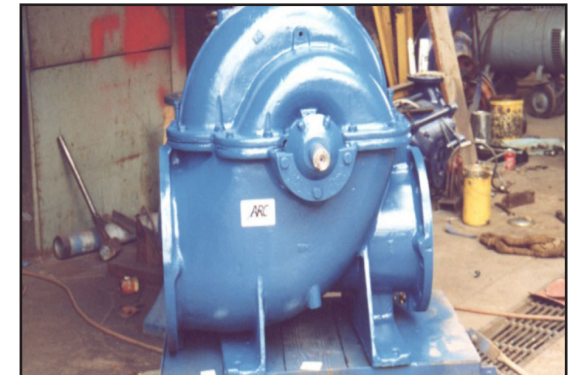
Assembled pump ready for delivery
