Prevent erosion and extend life of large trash racks covering cooling water intakes.

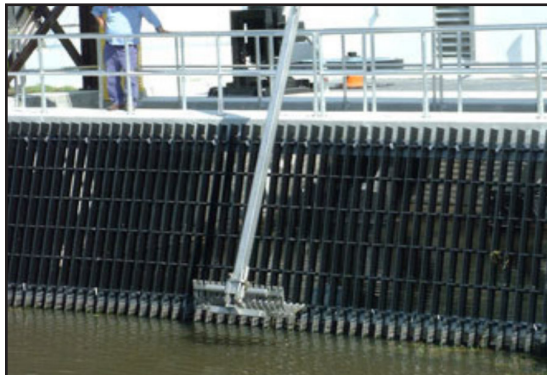
Racks eroded by debris pounded against them by waves, resulting in loss of low grade coatings and severe corrosion.

Racks showing corrosion due to impact

- Decontaminate for chlorides
- Grit blast Sa 2.5 with 3 mil (75 µm) profile

1. Apply **ARC 855** ceramic coating for corrosion and abrasion protection
2. Apply additional copper-based anti-fouling system to reduce marine growth

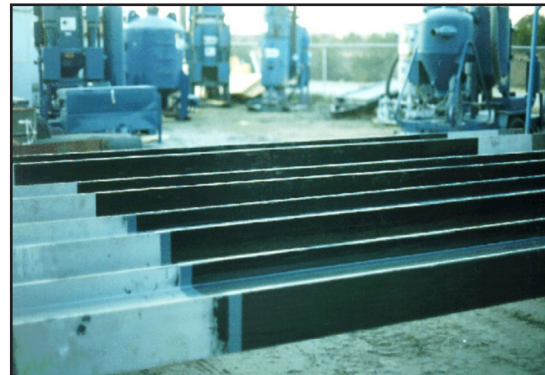
Two coats of ARC 855 - the end to be coated after welding

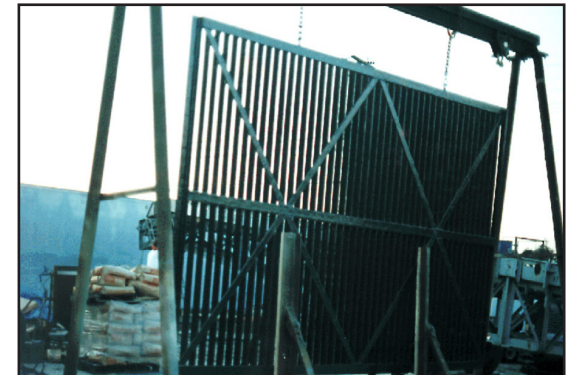
Finished product with ARC coating
