Challenge

Root Cause

Solution

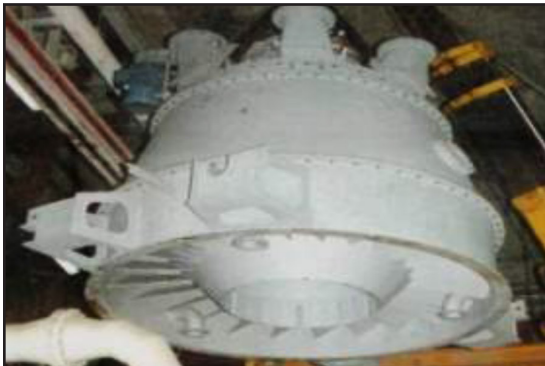
Abrasion from coal particles wears internal sections of pulverizers, reducing the performance of the mill.

Classifier section before protection

- Abrasive blast mill parts on-site to a Sa 2.5 with 3 mil (75 µm) profile

- Apply 5 mm of **ARC BX2*** to high wear zones outside of grinding zone (dampers, chutes, doorways, throw-rings, classifier cones, exhauster pieces, outlet elbows)

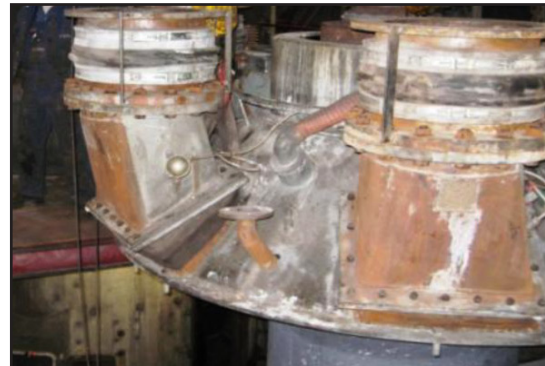
Top section protected internally with ARC being lowered into place

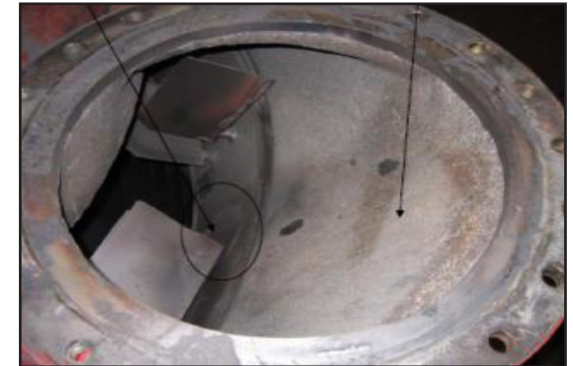
After over 5 years of operation less than 5% of the total ARC protected area required repair.

Outlet pipe after 40K hours showing small spots requiring repair with ARC
