The cyclones of an industrial dryer system required effective protection of the stainless steel substrate.

Provide a competitive, high performance alternative to ceramic tiles.

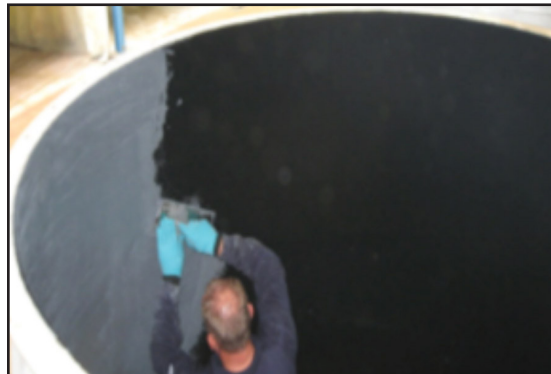
After cleaning, ARC 855 primer was applied by roller and ARC BX1 and ARC BX2 were trowel applied

- Prepped components in workshop
- Abrasive blast clean surfaces to Sa 2.5 with 3 mil (75 µm) angular profile
- Remove chlorides and contaminants

- Prime surface: ARC 855 at 12 mils (300 µm) DFT
- Trowel apply ARC BX1\* at 6 mm (.25") DFT
- Trowel apply second layer of ARC BX2\* at 3 mm (.12") DFT
- Repeat

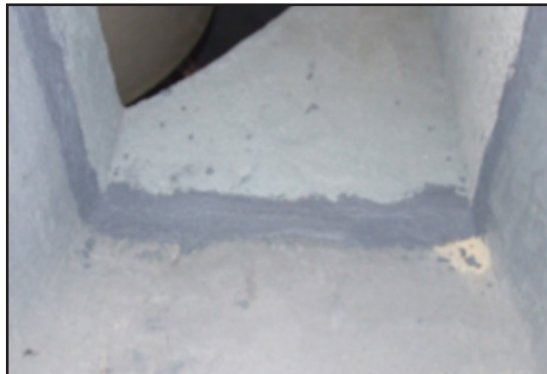
Nearly 100% of coating performed in work shop in 2.5 weeks by 3 applicators working 8-hour shifts

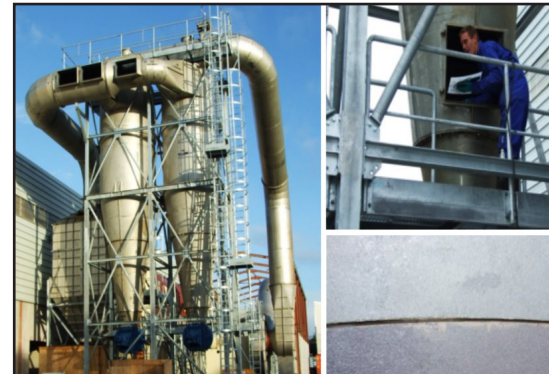
After assembly on site, repeat priming and coating on ID of flanges and weld seams
