Challenge

Issue

Loss of pump efficiency within 6 months reduces tailings disposal capacity, requiring additional pumps to be brought online.

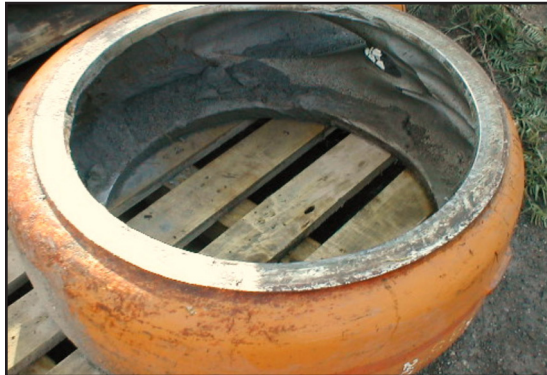
High velocity solids concentrations wore away >0.5" (>12.7 mm) of wet end.

Worn pump casing

- Decontaminate surface
- Grit blast to Sa 2.5 with 3 mil (75 µm) angular profile

1. Apply **ARC MX1** to areas with loss >240 mil (6 mm)
2. Apply **ARC BX2*** to areas with loss <240 mil (6 mm)
3. Brush on **ARC 855** @ 10 mils (250 µm)

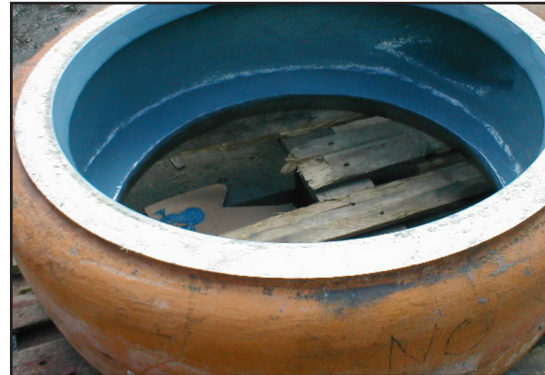
ARC BX2* and ARC MX1 with a top coat of ARC 855

*ARC BX2 is the "Bulk" package size of ARC 897

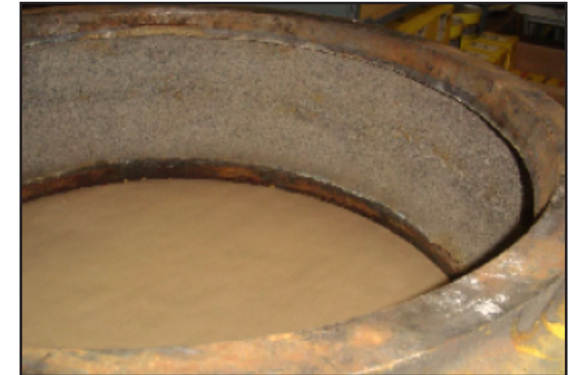
Volute after 6 months of runtime

- ARC-coated pumps extending MTBR to >12 months
- Minimal repairs required, and pumps easily returned to service within 72 hours
