## Challenge

Rubber liner in discharge chute that connects ball mill discharge hopper to slurry pump is wearing exposing metal to abrasion.

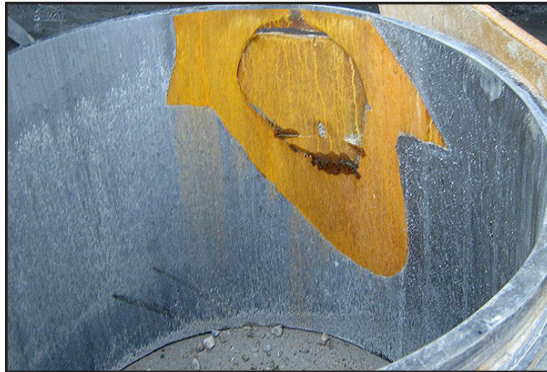
High volume of abrasive slurry surpasses abrasion resistance of rubber liner.

External metal patch welded on chute to extend MTBR.

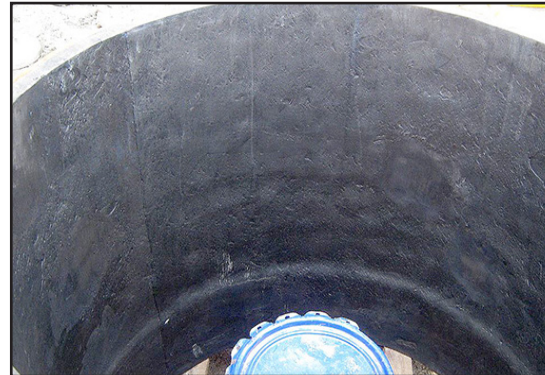
Rubber surface is prepared by roughening with flapper wheel.

- Clean surface from dust and particles
- Flapper wheel to Sa 2.5 with 2 mil (50 µm) angular profile on metal, and to roughen rubber lining surface.

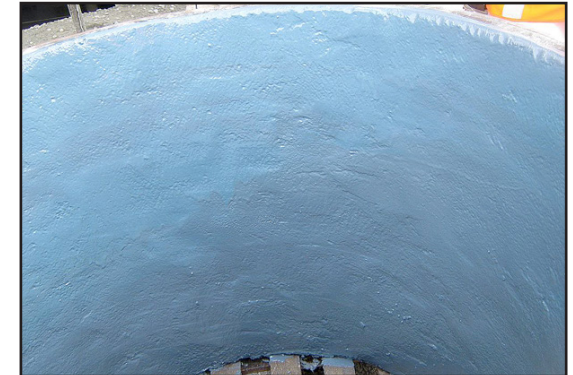
Chute protected with ARC BX1 over rubber and worn metal.

1. Apply **ARC BX1** to complete internal surface at a thickness of >500 mil (12.5 mm)

- ARC-coated chutes have extended MTBR to more than 3X that of rubber lined
