Challenge

Issue

A major supplier to a number of automobile manufacturers was having difficulty with the performance of the main press used in their production line.

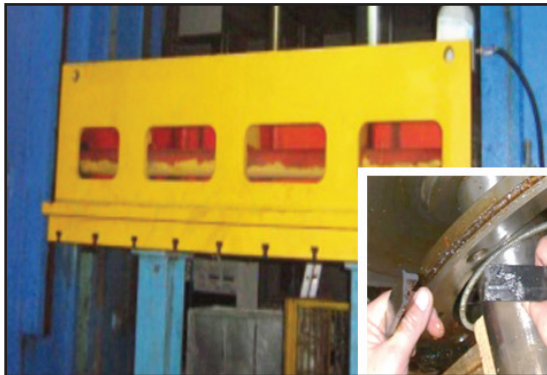
The primary piston seals rolled in the grooves during operation leading to premature failure.

Main hot forming press and close up of damaged seals (size - 230 mm bore).

A unique sealing solution combined a heavy-duty, bi-directional **Chesterton 20K** with a **19K** split replaceable bearing band.

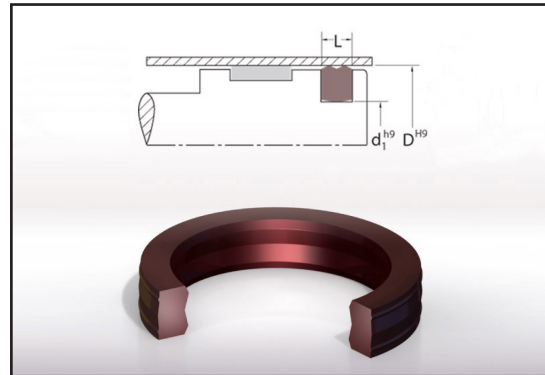
- **20K**: Unique thermoset material, (**AWC 800**) offers excellent wear and tear resistance
- **19K**: 40% glass-filled nylon (**AWC 660**) eliminates metal-to-metal contacts and offers similar carrying load as bronze

Double-acting, high-pressure hydraulic applications

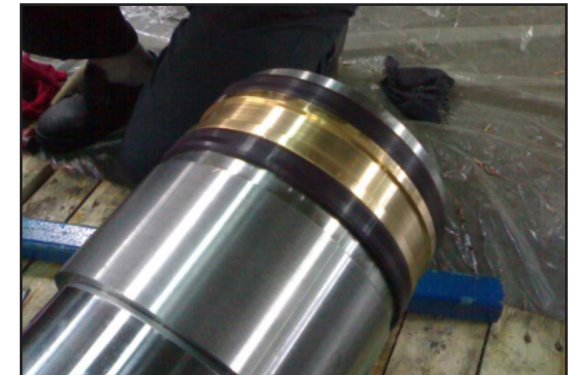
Modified piston design.

This sealing solution eliminated leakage of the cylinders on the main press and minimized scoring of the piston barrel and rod.
