## Challenge

A manufacturer of medium-density fiberboard (MDF) needed to increase the reliability of the main press cylinders on their large, single-daylight hydraulic presses. The number of cylinders per press range from 24-56.

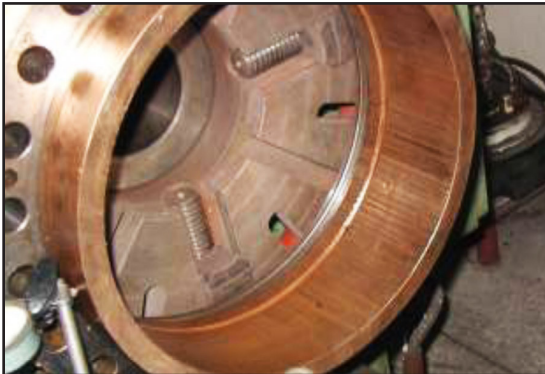
Excessive side loading was leading to premature wear of the bronze bushing and impacting press performance.

Damaged bronze bearing.

Retrofit the existing bearing groove to accept the **Chesterton 18K** and **19K** split replaceable bearing bands made from 40% glass filled nylon.

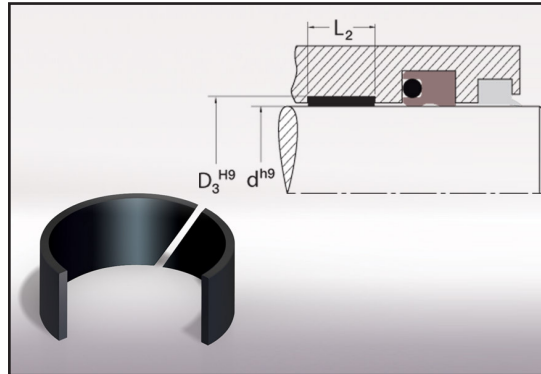
- Eliminate need to replace bronze bushings
- Provide the same carrying load as bronze
- High-performance thermoplastic polyimide resin that offers maximum heat stabilization
- Reduce radial movement, preventing metal-to-metal contact of moving parts
- Help prolong equipment and seal life

High-performance replaceable bearing bands for cylinders

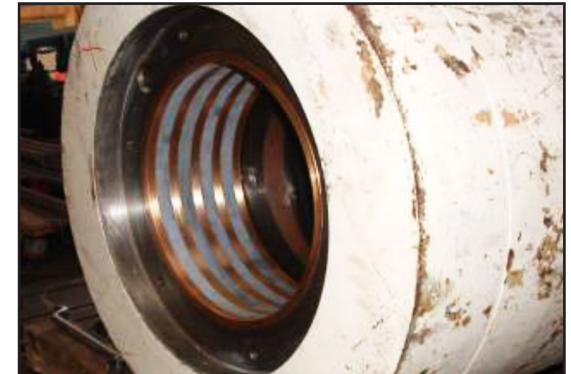
Replaceable bearing bands installed.

- Chesterton solution avoided costly reworking or replacement of bronze bearings\*
- Greatly lowered risk of recurring damage
- Extended life of moving components
- Prolonged seal life
