Challenge

An oil refinery needed to purchase excess spare parts and equipment due to extremely long lead times and the remote location of the refinery.

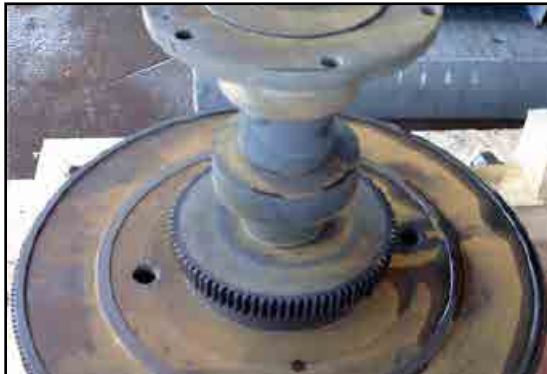
In storage, this inventory was exposed to extreme temperatures, humidity, and a corrosive environment. Many metal parts became prematurely corroded over time. These degraded assets have a high risk of being discarded, causing costly replacements.

Spare part in need of service.

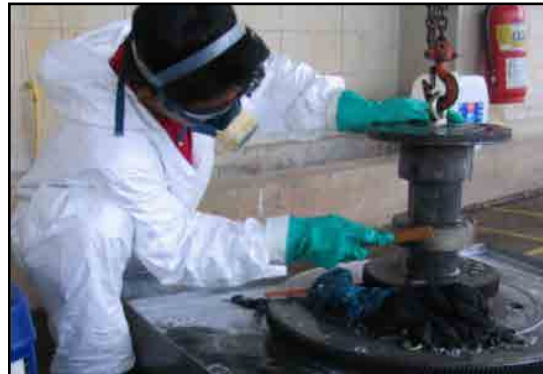
Cleaning corroded spare part with 338 Super Rust Remover.

- The parts were first washed with **Chesterton 338 Super Rust Remover**, a superior cleaner that removes rust and forms a layer for short-term corrosion protection.
- Next **Chesterton 740 Heavy Duty Rust Guard** was applied to provide long-term corrosion prevention for up to two years.

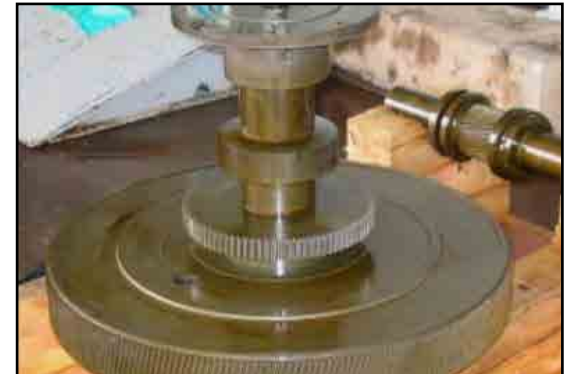
Cleaned spare part protected with a preventative coating of 740 Heavy Duty Rust Guard.

- Rust was effectively removed from the parts with the **338 Super Rust Remover**. Subsequent corrosion was prevented with a coating layer of **740 Heavy Duty Rust Guard**.
- Over \$600,000 in spare parts originally destined for disposal were refurbished and saved over a two-year period.
