# 800 GoldEnd® Tape Stops Leakage on Oxygen Gas Cylinders

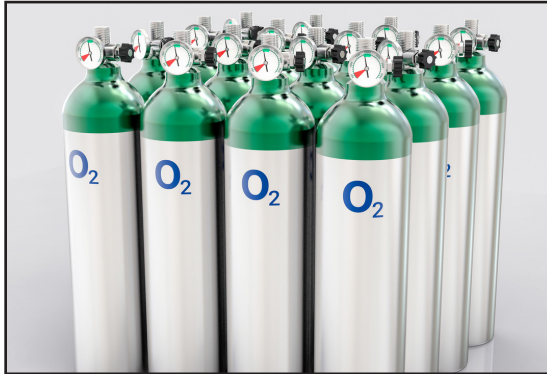
Cylinders handling oxygen at gas distribution center.

Medical-grade oxygen gas is explosive and very hazardous. Gas cylinders are typically sealed with a pure PTFE tape that is wrapped 5 – 8 times around the threads. Yet, the applied tape often shreds and tears, which results in leaks and requires special procedures to repair the leaking joint.

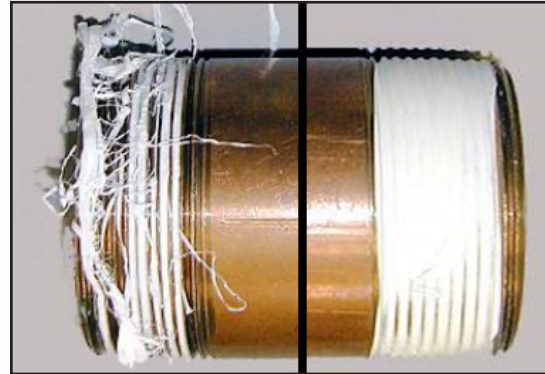
800 GoldEnd Tape was chosen for its ability to resist tearing and shredding.

**800 GoldEnd Tape** typically only requires 1.5 – 2.5 wraps to get a leak-free seal.

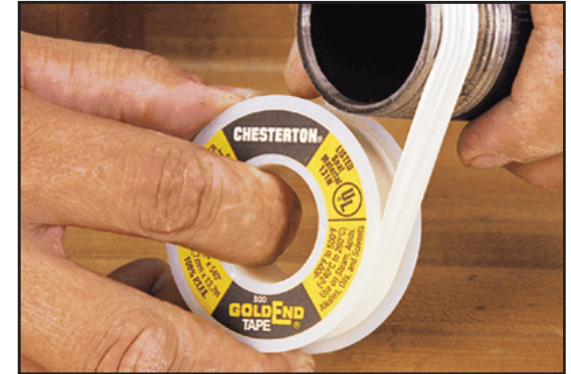
800 GoldEnd Tape has been recognized as an industry standard for oxygen thread sealing.

Due to the length and width of the fitting, 0.75 inch wide **800 GoldEnd Tape** was used to seal the joint. The depth of the “gas tight” threads required 2.5 wraps to properly fill the threads. Due to the ultra-high density of **800 GoldEnd Tape**, 1 spool of 0.75 X 540 inches was sufficient to seal 50 gas cylinder valves compared to the 4 – 5 spools required of a typical PTFE tape. After sealing the cylinders, no leaks were observed over the period of operation.
