Challenge

A municipality was operating eight large vertical centrifugal pumps for potable water. The pumps were experiencing reliability issues causing costly shutdowns every 2 – 3 weeks. The customer was unable to pinpoint what was causing the issue. Further review of the seal showed signs of dry-running conditions.

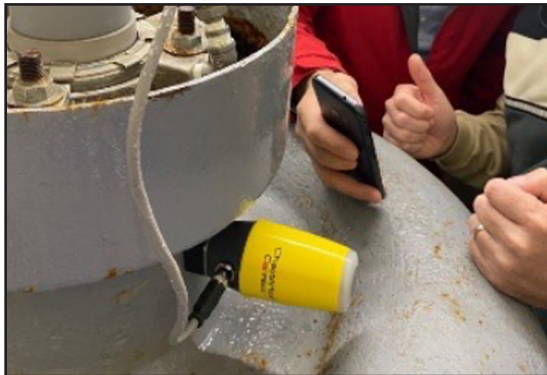
Chesterton Connect Sensor installed on the pump.

A **Chesterton Connect™ Sensor**, was installed on the **Chesterton® 442 Split Mechanical Seal** using one of the two available seal flush ports. The second flush port was used with a flush Plan 32. The aim of the test was to understand when, where, and what could potentially be causing issues in the pump's stuffing box.

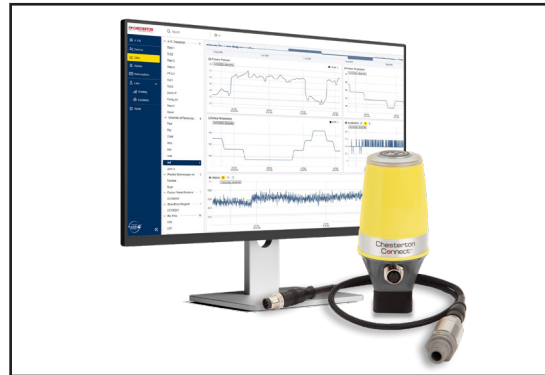
Using data recorded through the **Chesterton Connect Sensor**, the specialist quickly found an unpredicted pressure drop creating a vacuum in the stuffing box. Correlating the recorded pressure, temperature, and vibration data showed the vacuum was happening during start/stop operating cycles.

Data interpretation.

Thanks to the **Chesterton Connect Sensor**, the customer was able to identify the unexpected vacuum causing reliability issues, and further understand the frequency and duration of that vacuum within the equipment. The customer and the specialist were able to develop a solution to prevent these issues from occurring again saving them on average \$35,000 on pump repairs.

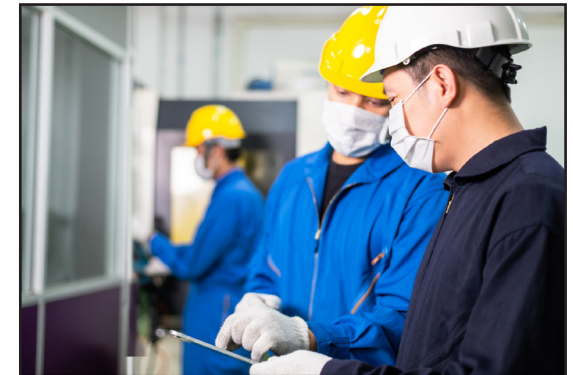
Data check on Chesterton Connect App.
