Challenge

A pulp mill was experiencing constant wear on a chip house conveyor screw, which caused costly repairs every shutdown and shortened equipment life.

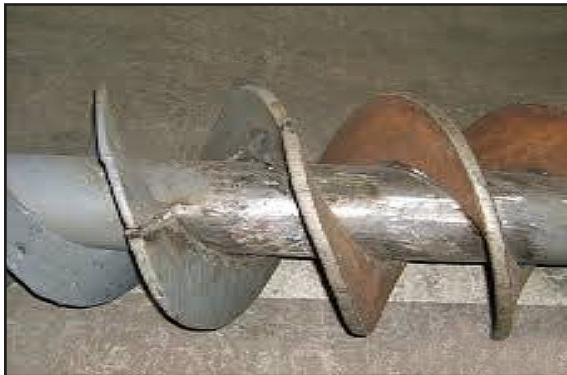
Screw is worn, cracking, and no longer efficient.

The surface was sandblasted to profile and the screw flights were coated with **Chesterton® ARC MX1** industrial coating. A thicker build of **MX1** was added on the flight edge and teeth.

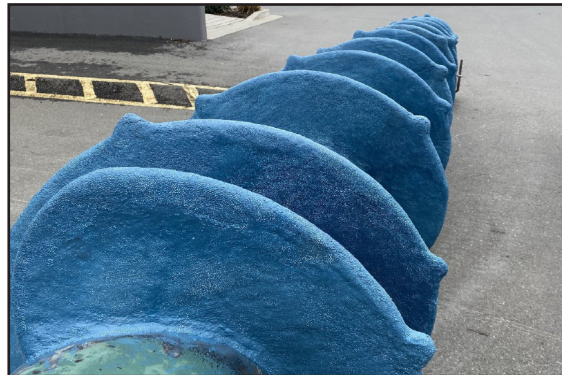
*The screw surface with **ARC MX1** industrial coating applied.*

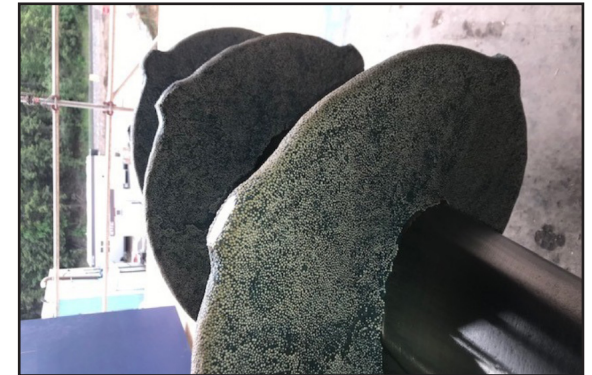
The screw was in constant operation for 14 months.

- The screw was in constant operation for 14 months with little metal loss on the teeth and flights.
- The customer was able to quickly repair any exposed metal and resume operation without the need for hot work permits. **The customer had an annual savings of \$10,000 as well as extending the life of the screw.**
