# 11K Rod Seal Solves Fluid Leakage in Large Press with Minimal Disassembly

*Metal Processing Industry  
Chesterton R11K with Spacer and R9K AER  
Polymer Seal Case Study*

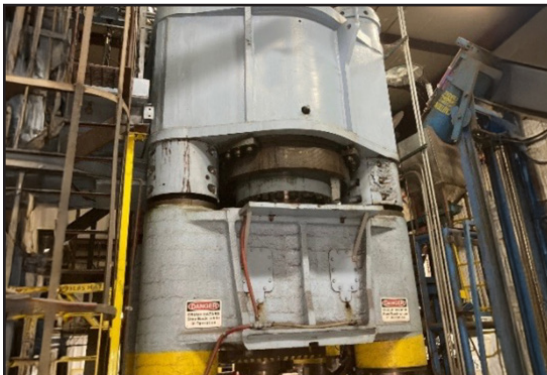
A 5,000-ton press had issues with leakage of hydraulic oil around the ram. The equipment was quite old and in need of repair. Due to the size of the equipment, it was not possible to completely disassemble it.

*5,000-ton compaction press was too large to disassemble.*

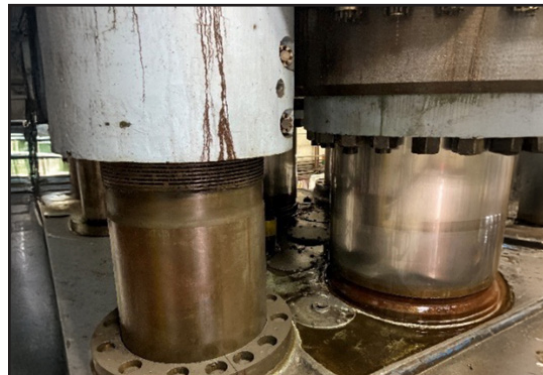
*Leakage around rams was evident.*

A **Chesterton® 11K Rod Seal** set with a spacer and a **9K AER Backup Ring** designed tight to the outer diameter of the packing chamber were selected to make installation less challenging.

Installation occurred overhead and the interference fit was intended to help in this process.

The Chesterton solution resulted in minimal equipment downtime with equipment soon returning to production. Further, the equipment was quite old, so the softer blue **AWC825** primary seal conformed well to the worn seal surfaces. Overall, the result of the solution was smoother system actuation with no oil leakage following installation.

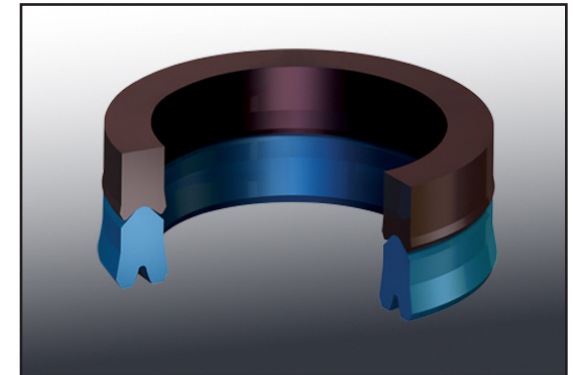
*Chesterton 11K assembly and drawing.*
