Challenge

An original Kaplan hydro turbine was installed in 1978, refurbished in 1996, and was being refurbished again. The contractor's biggest headache during the rebuild process is always the blade seals.

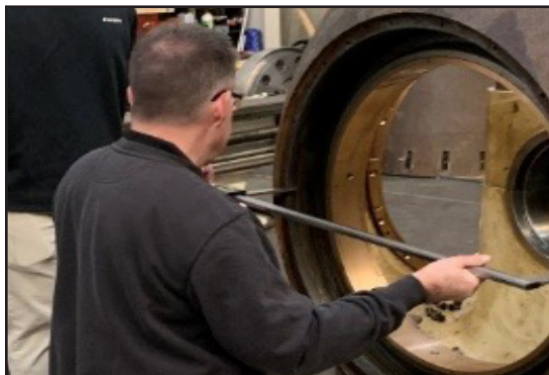
While measuring the existing blade seals and hub, Chesterton noticed the current seals were held in place by some type of metal bracket. The bracket was not shown on the OEM drawing.

Polymer seal engineer measuring hub.

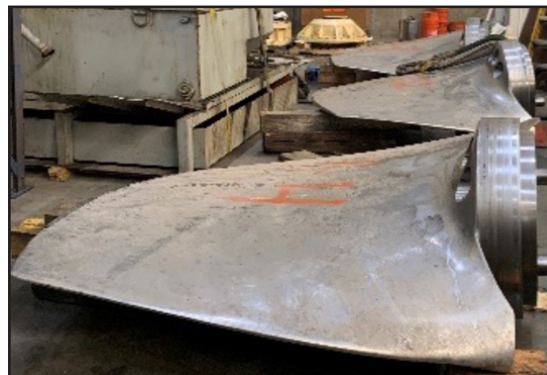
Turbine blades.

EPS engineering recommended **Chesterton® R22KN5 seals** and spacers. These were made from **AWC800** polyurethane for abrasion resistance and long life.

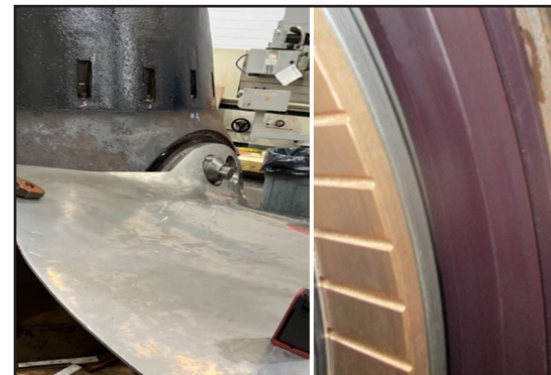
Installed seals and spacers.

The contractor installed eight new **R22KN5 Seals**, and spacers made from **AWC800** in May 2022 on the blades.
