# Quick Forging Press Sealing Solution Resolved

Steel Industry  
Chesterton® 11K Rod Seals, 11K Spacer Rings,  
W21K Wiper Seals  
Polymer Seals Case Study

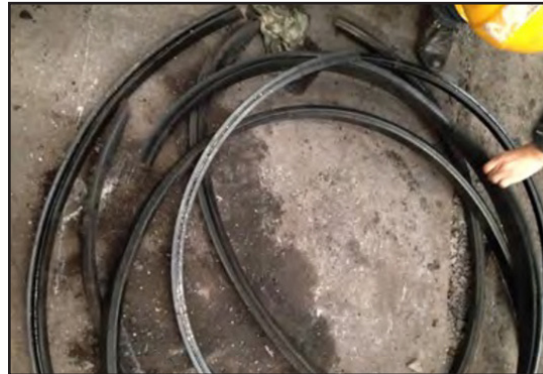
A fast forging machine was originally sealed by a rubber V-stack set. The rubber seals leaked and required replacement in less than 1 year. Replacement of the V-stack set took nearly a week. In addition, the performance of the V-stack was found to be poor and needed frequent adjustment.

Original rubber V-stack rings.

The V-stack set was replaced with a **Chesterton® 11K Rod Seal** and **11K Spacer Ring**. A **W21K Wiper Seal** was used to exclude contamination and extend seal life.

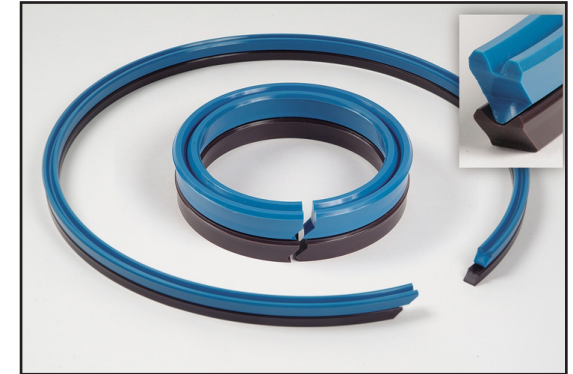
- **11K Rod Seal** 980,00 x 1030,00 made from AWC805/AWC800
- **11K Spacer Ring** 980,00 x 1030,00 x 088,50 made from AWC800
- **W21K Wiper Seal** 980,00 x 1010,00 x 995,00 x 018,00 made from AWC800

Chesterton 11K rings and AWC805/AWC800: a combination of hard and soft materials.

The leakage problem of the worn plunger cylinders was improved with the upgrade. The **Mean Time Between Repair** was increased from less than one year to 3+ years.
