Extended Chain Life with 720 CCG at Terminal Port

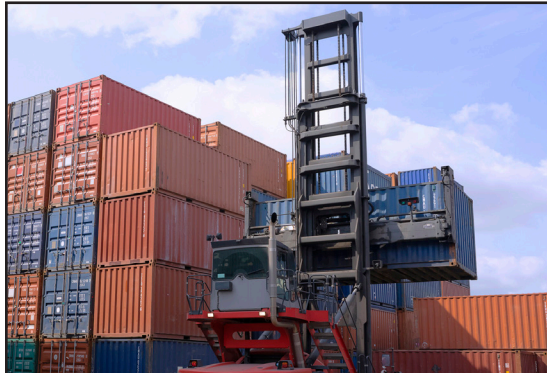
A marine port faced issues with a side loader chain used for lifting empty containers. Due to continuous outdoor operation and poor lubrication, the chain's lifespan was just 12 months instead of the expected two years. It showed excessive wear and corrosion as well as chain breakage during operation, leading to container damage and posing significant safety risks and downtime losses.

Side loader at a terminal port whose chains were failing prematurely.

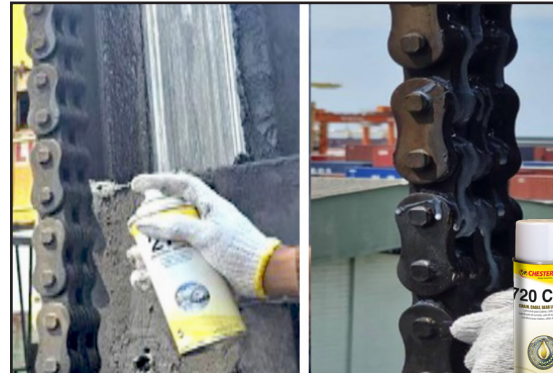
Cleaning with 274 Industrial Degreaser and lubricating with 720 CCG with diluent.

The Chesterton specialist recommended **Chesterton® 274 Industrial Degreaser** to clean the chains and **Chesterton 720 CCG with diluent** for lubrication and protection. **Chesterton 720 CCG** is a one-shot system designed to lubricate the inside of chains while also providing external protection, providing excellent wear and corrosion resistance.

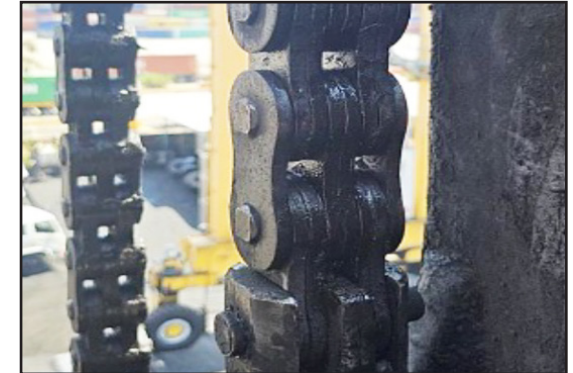
After using **Chesterton 720 CCG with diluent** for six months, chain measurements show little wear, as confirmed by a chain elongation gauge. The chain remains relatively free of rust and corrosion and remains flexible around sprockets. Based on these results, the lift chains are expected to meet or exceed their intended lifespan of two years, 2X life extension.

After using 720 CCG with diluent for 6 months, there was minimal corrosion or detectable wear.
