Challenge

Background

A stainless steel producer faced issues with wire rope lubrication of its hoist system. The lubricant failed to penetrate deeply enough to provide proper lubrication, resulting in unplanned wire rope repairs. In addition, excess lubricant squeezed out and contaminated the high-quality stainless steel coils. As a result, the coils required an extra operation step of cleaning before shipping to customers.

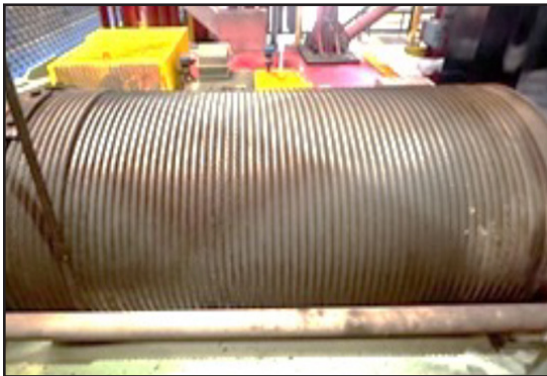
Wire rope hoist system inside the steel mill for moving stainless steel coils inside the plant.

They needed a product that could penetrate deep inside the wire rope and did not drip onto the finished product.

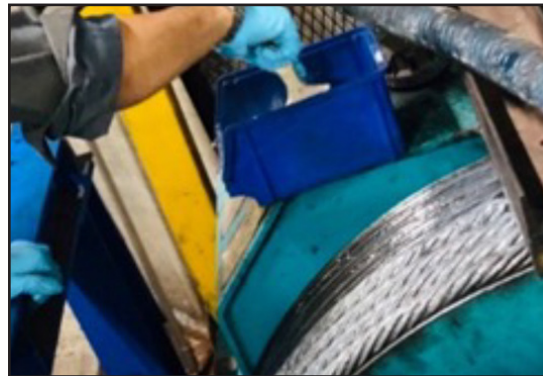
Chesterton 720 CCG with diluent applied with a brush on the wire rope.

Due to cleanliness requirements, **Chesterton® 720 CCG with diluent** was recommended. The **720 CCG** was easily applied by brushing it onto the wire rope.

As an oil-gel, **720 CCG** effectively penetrates inside the wire rope while being tacky enough to prevent squeeze-out, offering optimal lubrication without contamination.

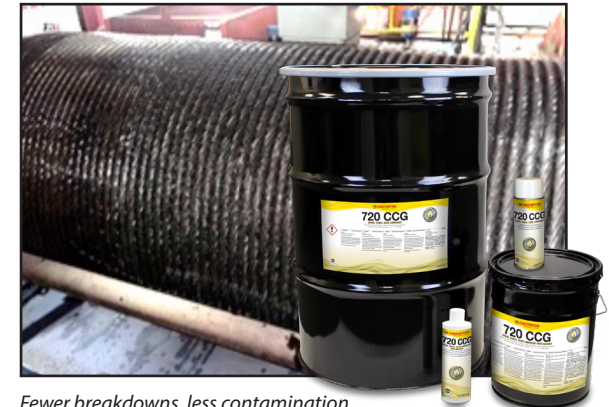
Fewer breakdowns, less contamination on the steel coils after using Chesterton 720 CCG.

After using **720 CCG** with diluent, the customer reported significant improvements:

- Less lubricant residue dripping onto or contaminating the finished stainless steel coils
- Extended re-lubrication cycles—from 1 month with grease to 4 months with **720 CCG**
- No breakdowns, leading to increased productivity
