Challenge

Background

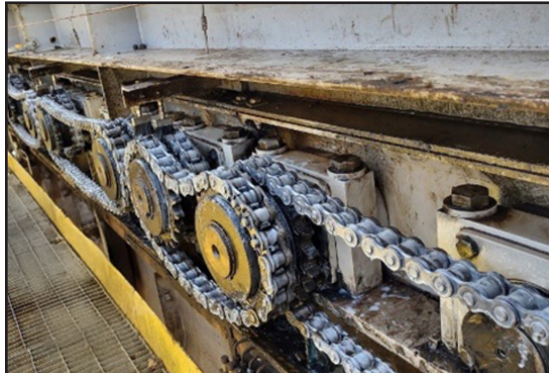
A log transport conveyor relied on grease for chain lubrication due to its outdoor exposure, requiring corrosion resistance. While the grease provided some protection, it failed to penetrate the pins and bushings, leading to significant wear and unplanned chain failures.

Customer was facing at least 4 incidents of chain breakage and replacement a year. The customer needed an oil-based solution that could penetrate the chain's interior while also forming a protective coating against water washout and corrosion.

Log transport chains in woodyard experiencing excessive wear.

A Chesterton specialist recommended **Chesterton® 720 CCG lubricant** to address both wear and corrosion issues faced by the customer. **720 CCG**, an oil-gel technology, penetrates deep into pins and bushings to reduce wear while simultaneously forming a protective surface coating that prevents water washout and corrosion.

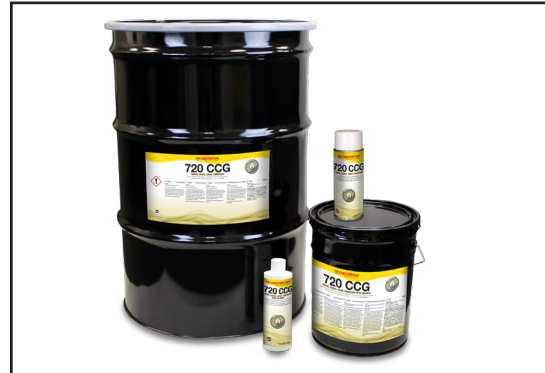
720 CCG with QBT™ oil-gel that penetrates the insides of chains as well as coats the surface from outside.

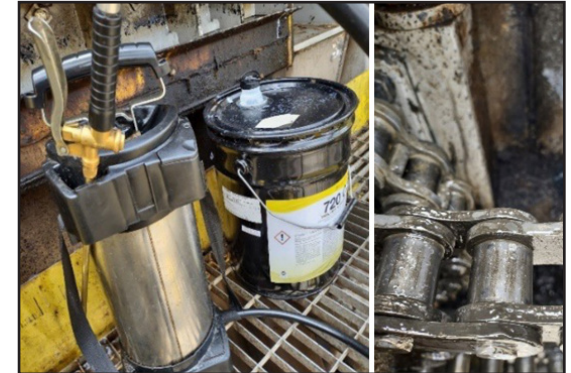
720 CCG being applied to the chains.

During the 1 year trial period, the customer experienced no chain breakage due to wear and significantly reduced corrosion from water exposure. Additionally, oil consumption dropped by up to 70%, while unplanned shutdowns and downtimes were significantly reduced, leading to a noticeable increase in operational efficiency.
