## Challenge

A paper mill had leaking issues on a 13" hydro re-pulper, used to break down any defective paper to then be re-processed, requiring air to constantly be blown on the shaft to clear any pulp debris.

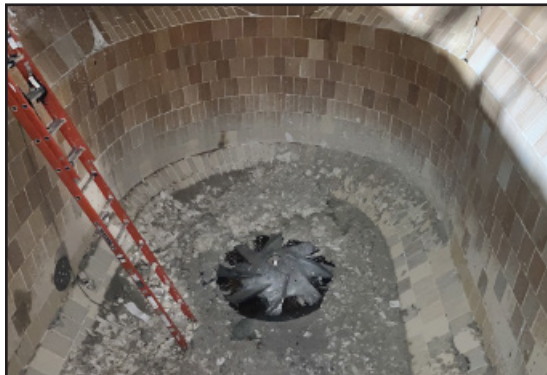
The equipment is very hard to access, making any packing adjustments difficult and a safety a concern. As a result, packing adjustments were neglected which led to further issues.

Top view of re-pulper "pit" where defective paper is ground by the blades.

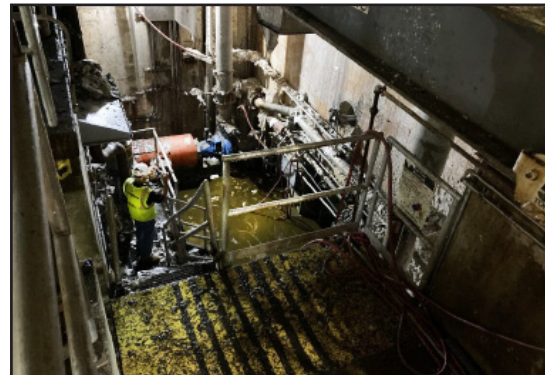
Previously, maintenance had to go down into this "pit" to adjust the packing.

A pressure regulator was mounted outside of the re-pulper "pit" so it can be adjusted without hunching over in the oily water.

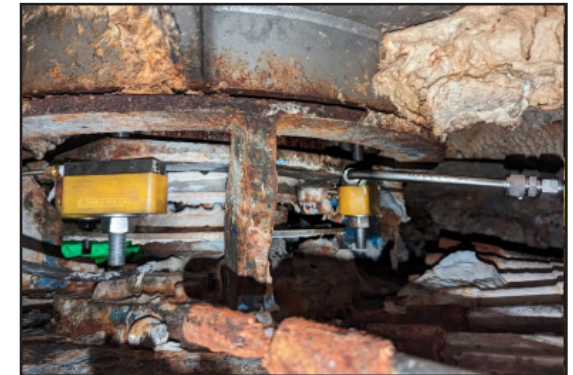
After installation and the equipment restart, the **AMPS technology** is sealing with minimal leakage.

Equipment with **AMPS technology** installed on all four bolts.

All four bolts were fitted with **Chesterton AMPS™** double cylinder units and pressurized to 30 psi.
