Challenge

Background

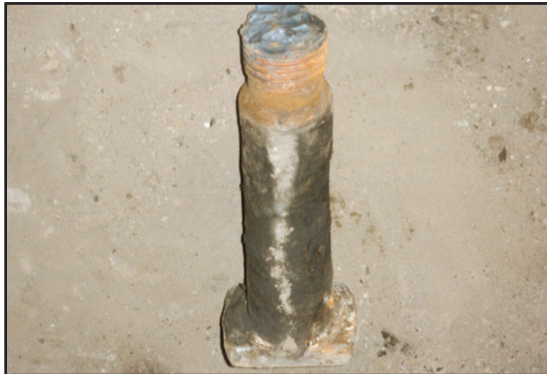
- Abrasive wear and heavy loads caused conveyor chain hinge bolt to fail. Each year about 30 chains had to be repaired.
- Most of the connecting chain hinge bolts could not be removed due to corrosion.
- For every chain, 10-20 hinge bolts were required to be removed by cutting torch.
- 30 chains x 15 bolts: 450 bolts
- \$150/bolt: \$67,500

Customer originally applied graphite paste diluted with mineral oil.

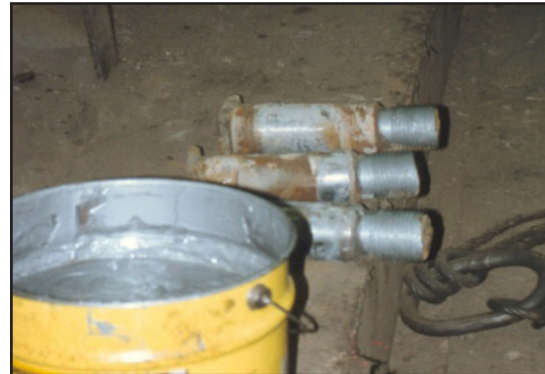
New hinge bolts and nuts are coated with Chesterton 725 Nickel Anti-Seize.

- Apply **Chesterton 725 Nickel Anti Seize** to the pin and bolt assembly during repair.
- Threads and pin were heavily coated with lubricant from 20 liter pails applied with large brushes.
- The conveyor was put into service and evaluated after 12 months during the annual scheduled PM of the coal conveyor.

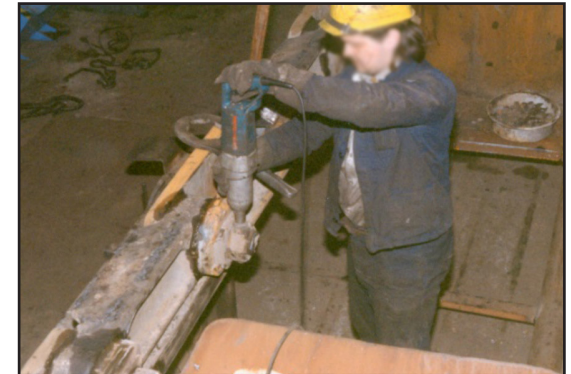
Hinge bolts were easily removed during scheduled maintenance.

With the use of **Chesterton 725 Nickel Anti Seize** almost all bolts could be removed during annual chain/conveyor maintenance.

- Hinge bolts showed 50% less wear
- Disassembly time was reduced by 75%
- Greatly reduced downtime and loss of production
