Challenge

A hydropower plant using Kaplan turbines noticed that their runner blades were not working at optimum efficiency due to leakage of the blade runner seals.

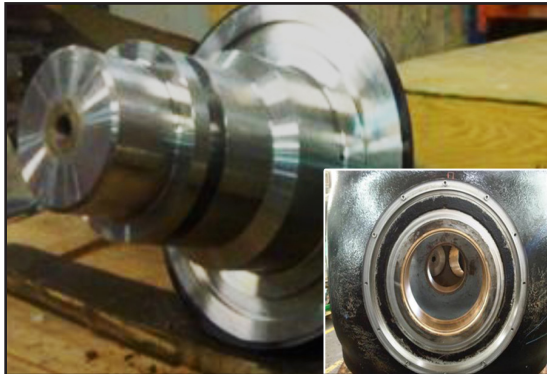
Failing OEM rubber stacked v-rings had to be replaced every few years leading to lost downtime and unplanned maintenance.

Equipment showing internal housing and runner blade.

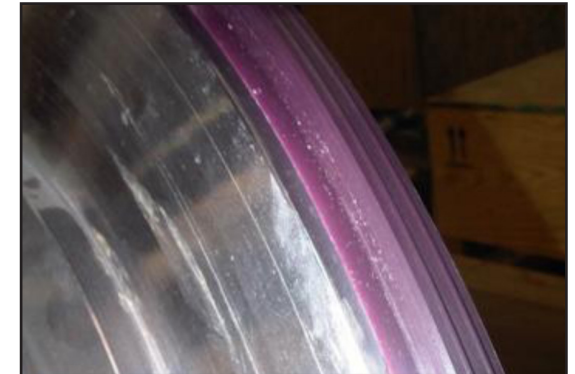
Seal shown installed onto the runner blade hardware.

Use two **Chesterton Kaplan Runner Blade Trunnion Split Seal** back-to-back, creating a positive seal both internally and externally.

- Helped the customer get the equipment up and running quickly, saving valuable time and money.
- Zero leakage for over 4 years, eliminating the environmental and safety concerns as well as associated costs.
- Blade runners are working at optimum efficiency.
