AMPS™ Technology Reduces Leakage and Improves Safety in Paper Mill

Pulp and Paper Industry
Chesterton AMPS™ Technology
Packing Case Study

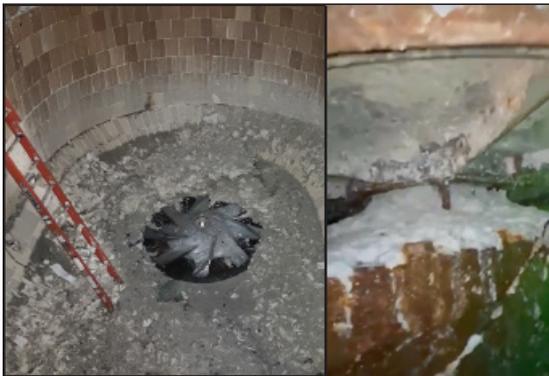
Top view of the re-pulper "pit" where waste paper is ground by the blades. The lower right image shows the exterior bottom of the tank.

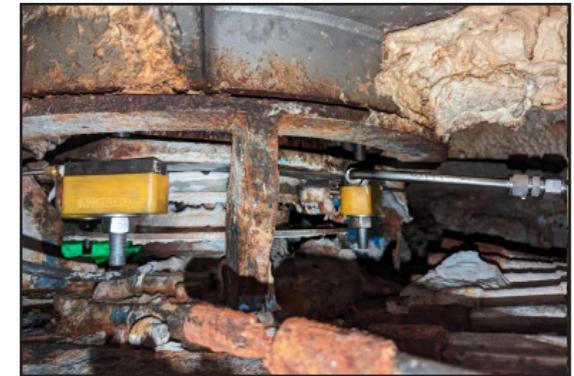
Equipment outfitted with *AMPS technology* on all four bolts, with the pressure regulator installed remotely in a safe, accessible location.

All four bolts were fitted with *Chesterton® AMPS™* double cylinder units and pressurized to 30 psi.

A pressure regulator was mounted outside the re-pulper "pit" allowing for easy adjustments without the need to crouch in the oily water and pulp slurry.

After installation and the equipment restart, the *AMPS technology* is sealed with minimal leakage.

The packing can be adjusted from outside the "pit," improving safety and allowing for easier adjustments during maintenance checks.
