A chemical plant in Sweden was running a decentered screw pump in a latex process.

This equipment had repeated seal issues. After numerous failures from previous sealing systems, the customer agreed to upgrade to a new custom double seal with a barrier fluid system monitored by a Chesterton Connect™ sensor.

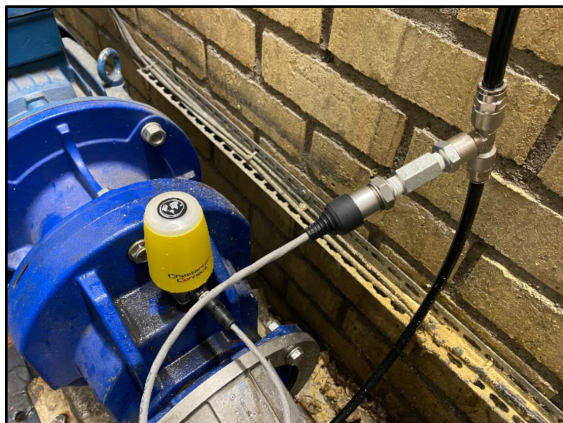
Chesterton Connect set to monitor barrier fluid.

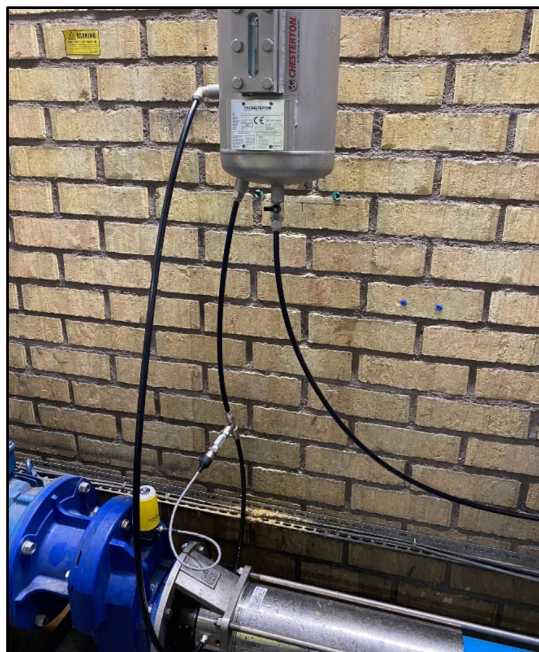
A Chesterton Connect sensor, was installed to monitor the barrier fluid line of a special Chesterton S20 Cassette Seal with BBS Buffer Support Tank System for Dual Seals.

Installation overview.

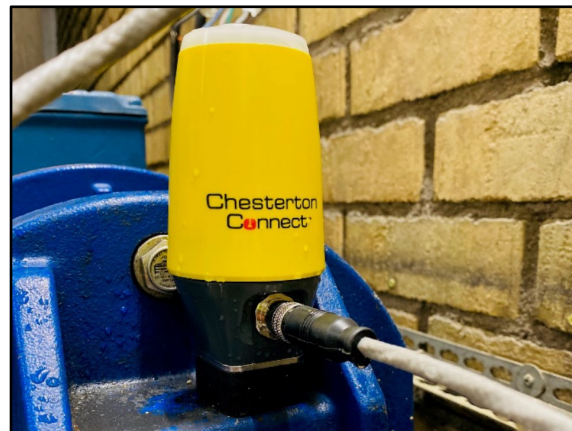
Chesterton Connect sensor unit installed.

This complete sealing system offers not only the reliability of the special design of the seal itself, but also the continuous monitoring of the closed loop support system, critical to the longevity of the application.

The pump has since operated with no issues.
