Challenge

Background

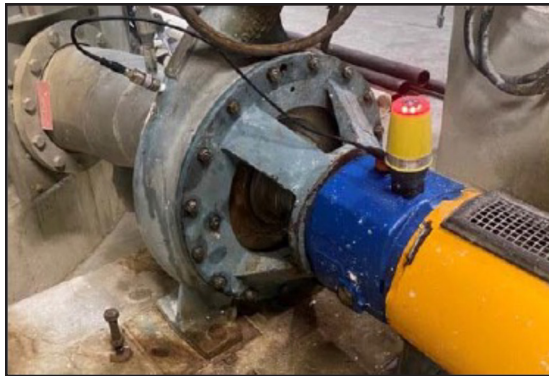
Chesterton Connect Sensor monitoring discharge pressure and bearing temperature.

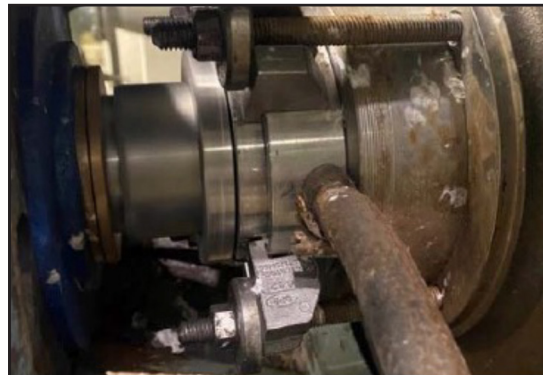
Chesterton 1510 Cartridge Seal installed on a centrifugal pump.

A **Chesterton® 1510 Single Cartridge Seal** installed to replace the original double seal with a small flush. To monitor the seal and pump operation, a **Chesterton® Connect™ Sensor** was installed to measure discharge pressure, temperature, and equipment vibrations.
