Challenge

Regular spills of acid damaged existing coating and underlying concrete after 1 year. Safety risk in traffic areas, and associated environmental fines, were also present.

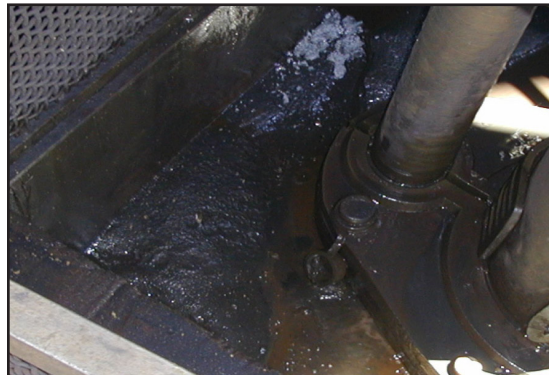
30% H₂SO₄ attacks cement in concrete, damaging sumps, tank pads, and pump bases.

Pre-existing condition of concrete

- Pressure wash and decontaminate concrete
- Mechanically roughen to CSP3 finish

1. All surfaces primed with **ARC 797**
2. Pitch to grade and top coat with a .25" (6,4 mm) of **ARC 988** system

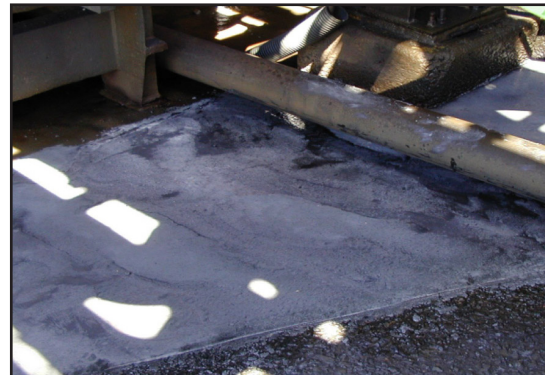
Initial application completed in 2002

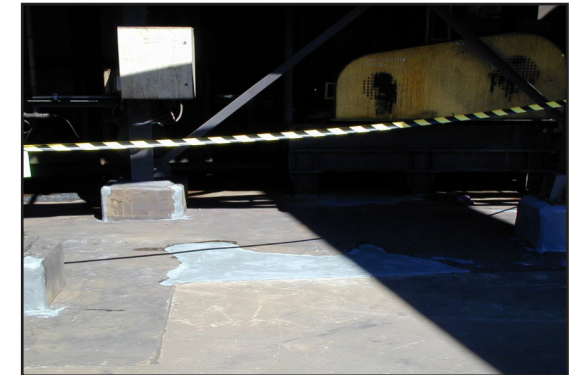
- Achieved goal of protecting concrete from acid leaks
- Safety risks from damaged concrete addressed
- ARC coated and lined surfaces are damage free for over 8 years
- Client continues to use **ARC 988** as preferred lining system for concrete protection in all plant areas exposed to acid

ARC coated surfaces with minimal repairs indicated in 2010
