# \$90K Savings and Improved Sealing Solution for Grinding Mill

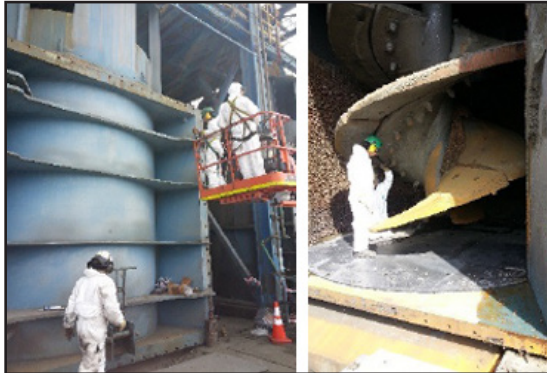
A customer at an Ore Processing site used RTV silicone to seal the door of a vertical grinding mill. The adhesive was so strong that the door could not be removed for scheduled maintenance.

To open the door, four hydraulic rams were used. The force needed to open the door was so high that the door would sometimes deform, making resealing difficult. It required 4 to 6 workers and three hours to scrape off the silicone material.

Vertical grinding mill.

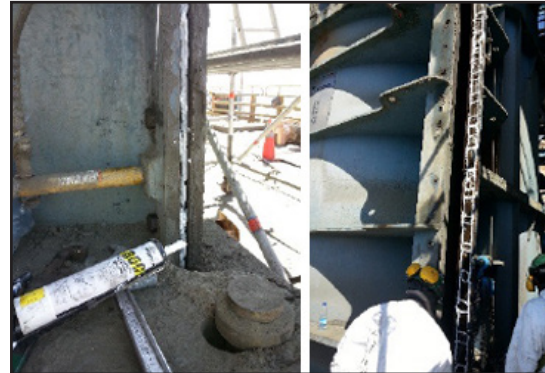
860 MPG applied to the door flanges and mill housing.

The silicone material was removed from the surfaces with scrapers, strippers and grinders. **860 MPG** was applied on mill housing and door flanges (as shown in picture). The 860-curing agent was sprayed on the 860 polymer, and the door was assembled. The bolts were tightened to form a tight, metal to metal seal.

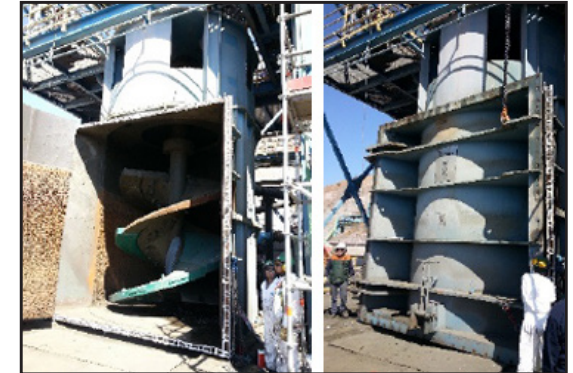
Grinder door closed after applying 860 MPG.

The use of 860 MPG has significantly decreased the force required to open the door, and as a result, no deformation has been encountered.

The introduction of **860 MPG** has made the overall process easier and reduced the labor time. The polymer comes off very easily, saving three hours of downtime for every maintenance cycle and resulting in savings of \$90K USD.
