## Challenge

A wastewater facility in Texas was having clogging issues, due to ragging, in their submersible pumps. The frequent clogging created cavitation and resulted in pump vibration which caused serious damage to the pumps and components. Costs for repair ranged from \$18,000 to \$35,000 per pump.

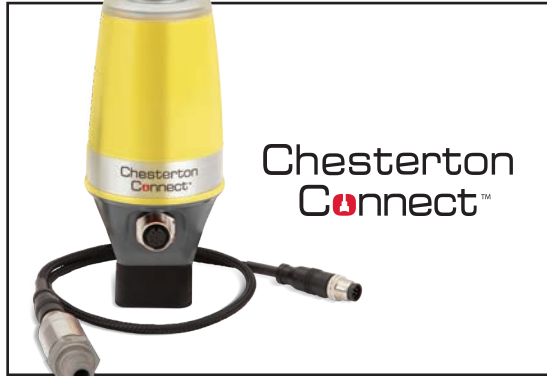
Chesterton Connect Sensor.

Chesterton® specialists met with facility personnel to discuss options to reduce both the significant maintenance cost and the pump downtime. **Chesterton Connect Sensors** were installed on the discharge piping of the pump to remotely detect vibration in excess of pre-established levels, indicative of clogging and email personnel of vibration issues.

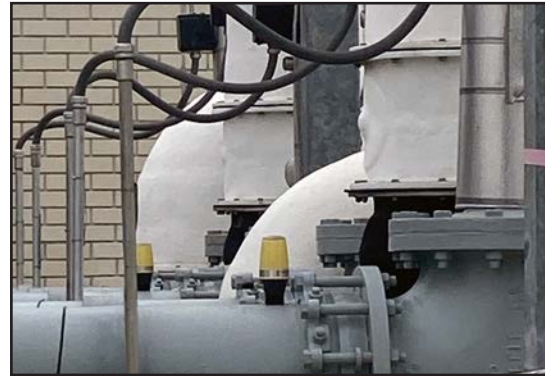
Submersible pumps with Chesterton Connect Sensors.

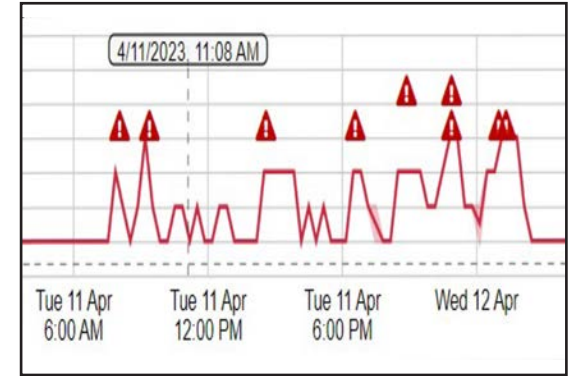
Automated alerts from the Chesterton Connect Cloud.

The **Chesterton Connect Sensor**, in combination with the **Chesterton Connect Cloud** were able to warn facility personnel of increasing vibration as the pump suction became clogged. This allowed maintenance crews to clean out the ragging prior to significant pump damage and quickly return to normal running conditions. This saved the facility the cost of pulling the pump and completely rebuilding.
