Challenge

A slurry pump stuffing box was showing erosion and corrosion attack. The packing was becoming loose due to the box wearing out on the ID.

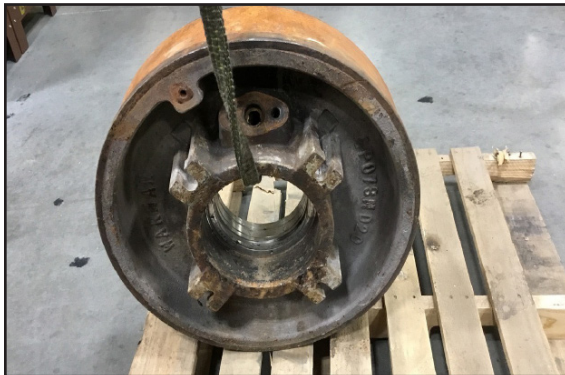
Stuffing box showing erosion and corrosion.

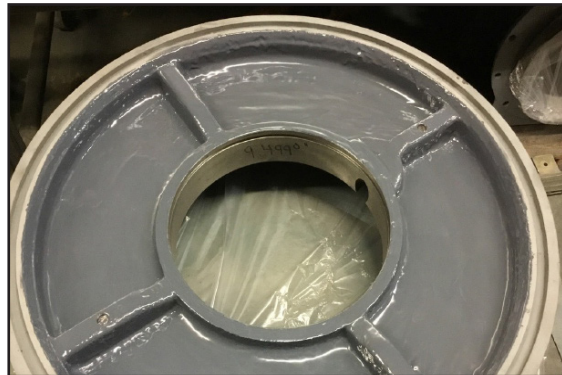
ARC SD4i applied to the stuffing box.

Chesterton® ARC SD4i was applied to the inside and a new bolt on SS stuffing box with an integral **SpiralTrac® Environmental Controller** was put in place. A nice repair program for our customer, reusing old parts and making them new again.

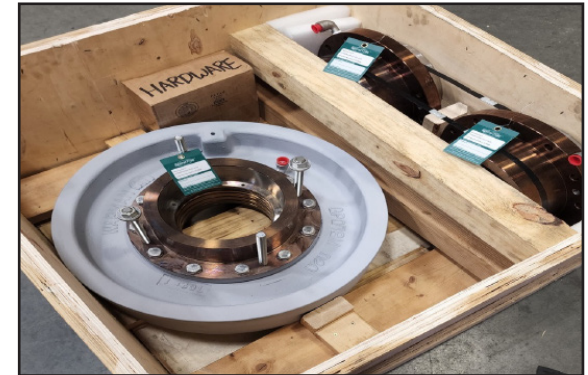
There was less wear on the stuffing box. With the packing stabilized, there were less repacking errors, saving downtime and costly mistakes. The flow to the ID was better controlled.

The flow to the IC of the packing is better controlled.
