Challenge

Transport screw flights were failing under abrasive load. This resulted in poor bark transport to boiler.

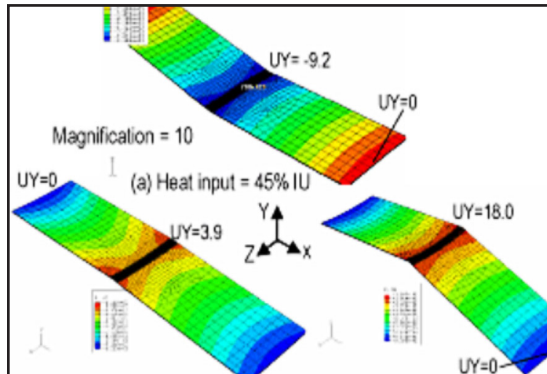
Severe abrasion on the drum and flights from bark processing. Hard-face welding distorted equipment, adversely impacting performance.

Weld-induced distortion patterns

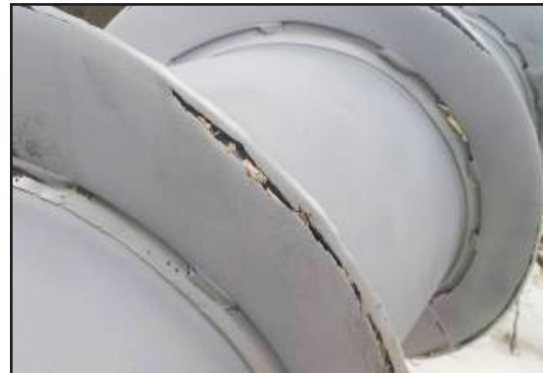
Cleaned and blasted surface

- Steam clean at 100 bar (1400 psi)
- Grit blast to Sa 2.5 with 3 mil (75 µm) angular profile

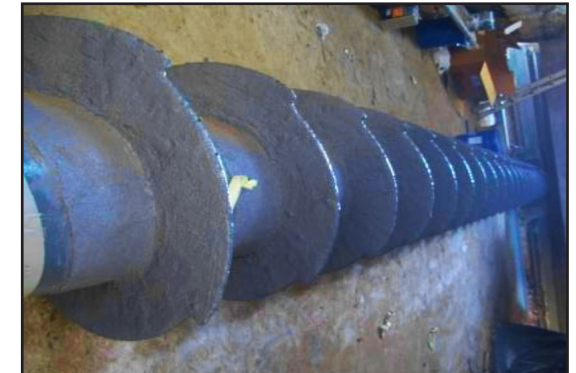
Repaired transport screw

1. Apply **ARC BX2*** to drum and drum/flight transition. ½ inch (12 mm) at cove and up to leading face of flight
2. Apply 2 coats (alternating colors) of **ARC 855** ~DFT: 60 mils (1.5 mm)

- Months of optimal service: >48
- Minimized inefficiency related to weld induced distortion of flights
- 48 month cost avoidance*: \$40K
